Data Structure Report: No.107

The 'mortuary house' at Saul, Co. Down

THE 'MORTUARY HOUSE',
SAUL, CO. DOWN

CAF DATA STRUCTURE REPORT 107

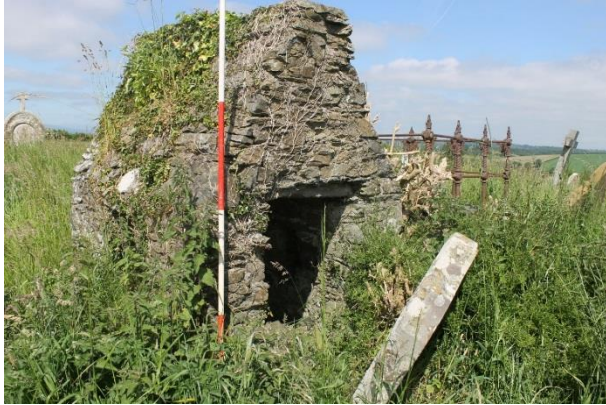
Figure 9 (Left) – The opening at the east of the 'mortuary house' which is unlikely to be an original feature. Figure 10 (Right) – A piece from a headstone has been reused above the lintel at the eastern end.

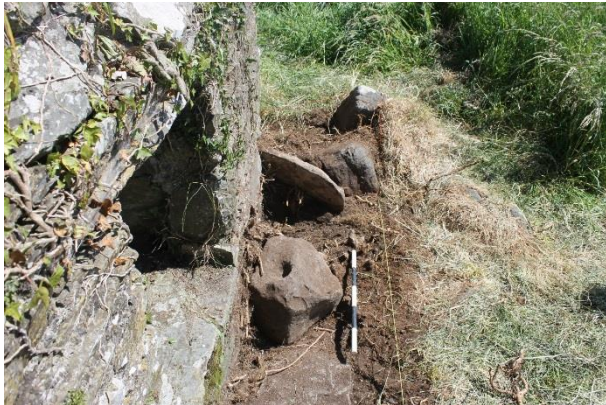
recovered from this context. Revealed on removal of the sod (c100) and sitting on the loamy layer (c101) was a possible bullaun stone (Figure 18). This was not in its original position, but had been placed beneath the opening in the southern wall of the 'mortuary house' perhaps by someone who came across it elsewhere in the graveyard and moved it here, recognising it as a feature of possible antiquity.

Figure 18 – The possible bullaun stone on the surface of the topsoil (c101), looking east.

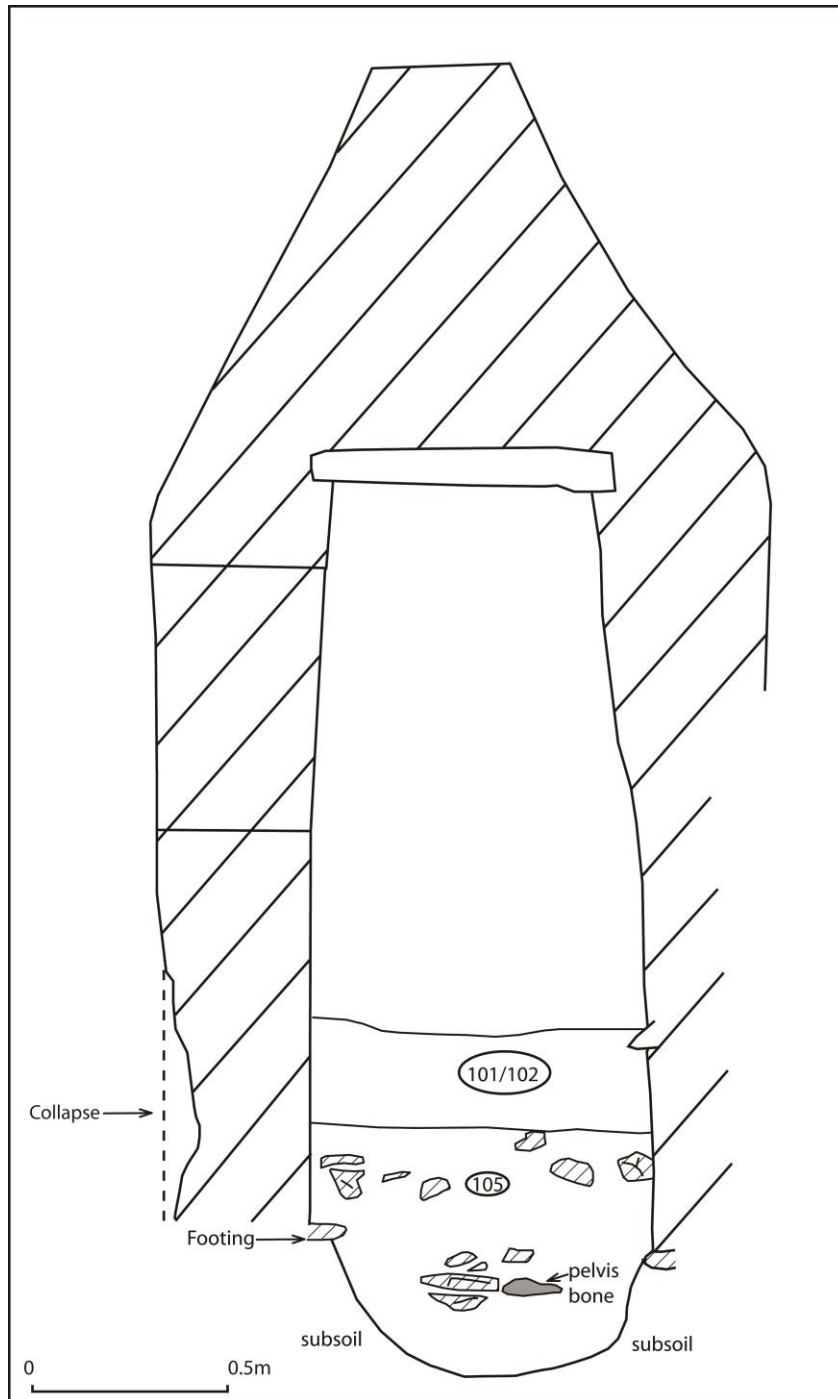
Figure 21 – East facing section and elevation of the interior of the building.

The graveyard soil was excavated to a depth of 0.7m on the interior of the structure (see Figure 21) revealing the orange brown clay subsoil beneath and a clay pipe stem was found within it (c105), below the level of the footings. The graveyard soil also continued to the base of the wall of the structure at the west and was not fully excavated beyond this point (Figure 24). It is apparent that continual digging has taken place within and around the structure over many years to inter burials and

to deposit disarticulated remains. Unfortunately this has meant that any original floor levels or associated layers have been dug away.

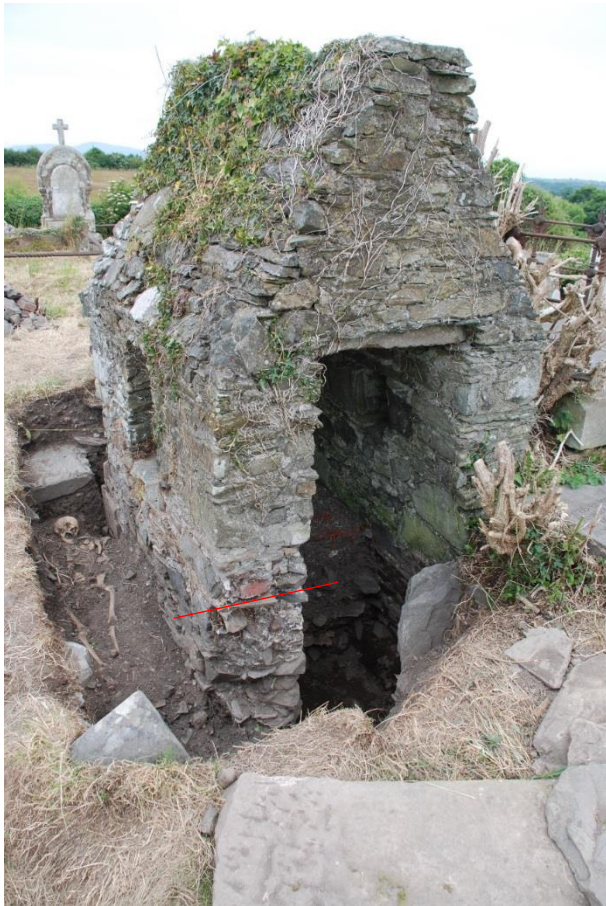
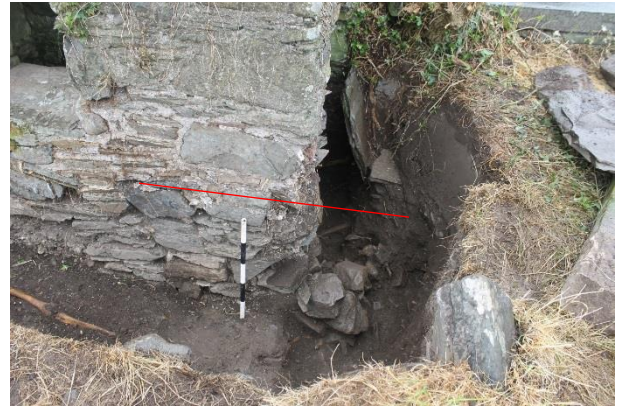
Figure 25 – The eastern end has been tidied, faced and repointed above ground and the below ground portion has remained untouched by the conservation work. It is apparent from the below ground portion of the wall that it would have originally extended further eastwards. The red line indicates the present ground level (Left – looking east-north-east. Right – looking north).

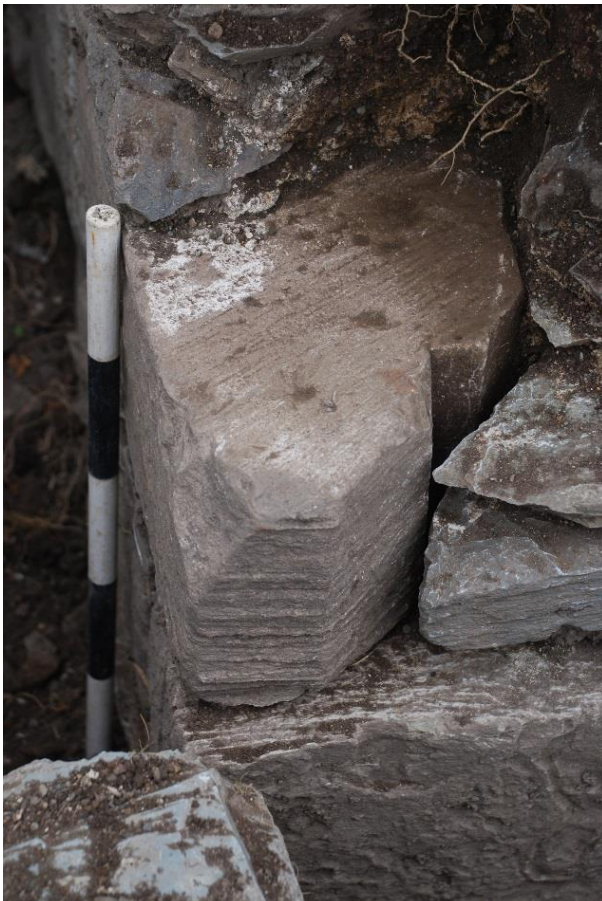
Figure 26 – Dressed stone fragment at the south-west corner, reused in the construction of the 'mortuary house'.

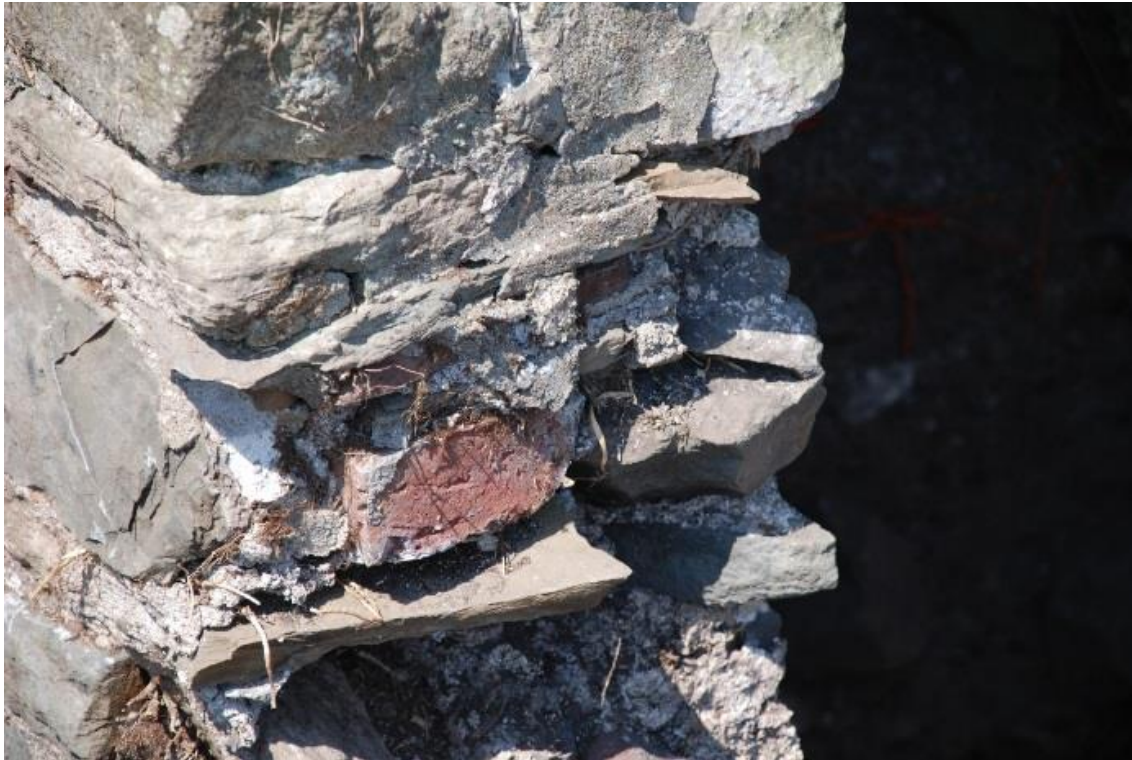
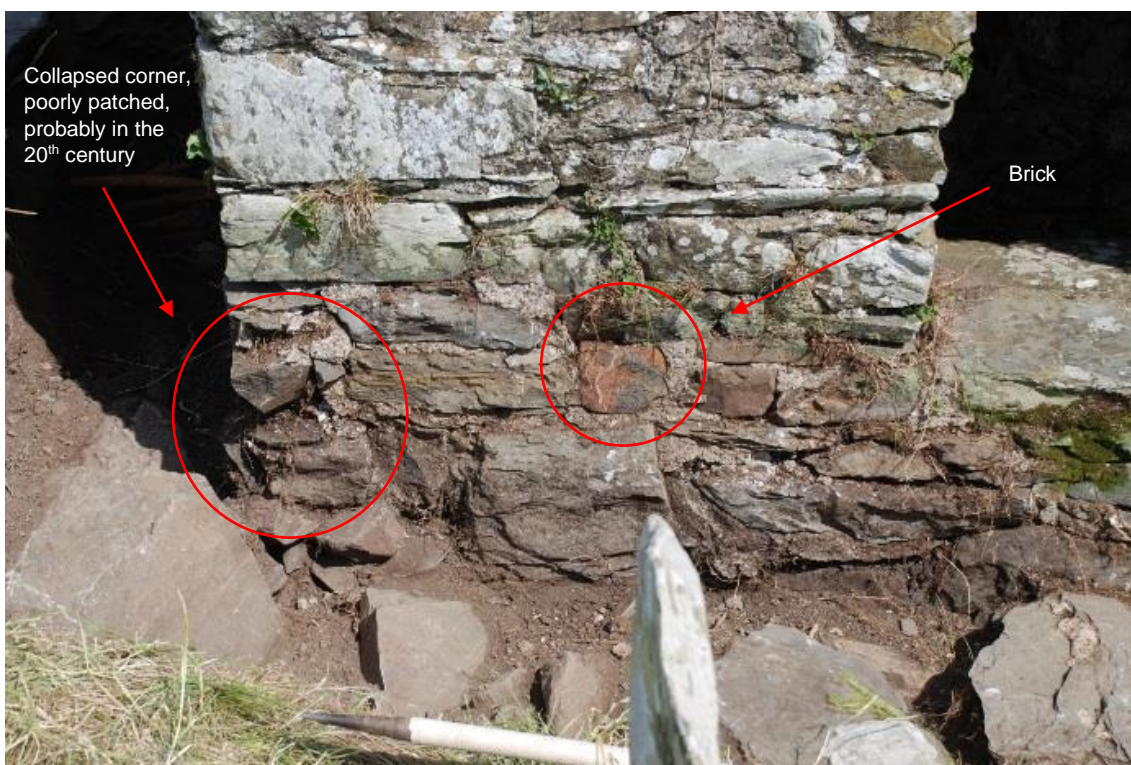
appears to have once extended further eastwards. That the current opening at this end is later was suggested by the reuse of a headstone above the lintel as well as the lack of corbelling at the eastern end and was confirmed during the excavation. The ends of the walls at the eastern end are well faced and finished above ground level, however, below ground level it is evident that the wall continued further eastwards and had collapsed at this point (Figure 25). At the western end cut architectural stone was found to have been re-used within the walls (Figure 26), indicating a construction date following the demise of the medieval buildings at Saul, presumably sometime after the dissolution of the monasteries when the lands were granted to the Earl of Kildare in 1542. Sometime after the modification at the eastern end, damage at the south-west and south-east corners was poorly patched using brick in places (Figure 27).

Figure 27 – Brick used in 20th century repairs to the building, at the south-east corner (above) and in the southern façade (below).
