Monitoring Report No. 81

**Site to the rear of Nos. 1 and 3 Bridge Street
Kilkeel
County Down**

AE/07/111

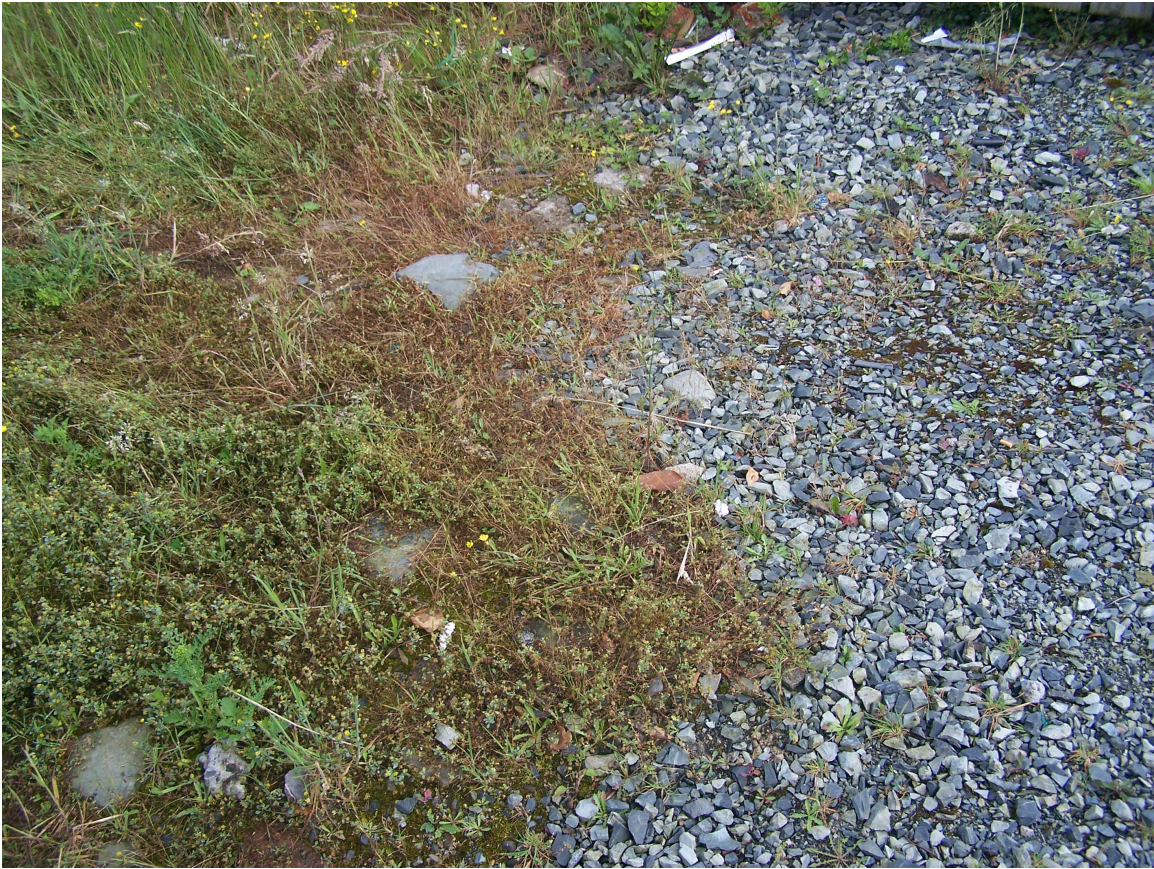
Plate Two: Mixed gravel and building rubble deposit (Context No. 101) prior to excavation, looking north.

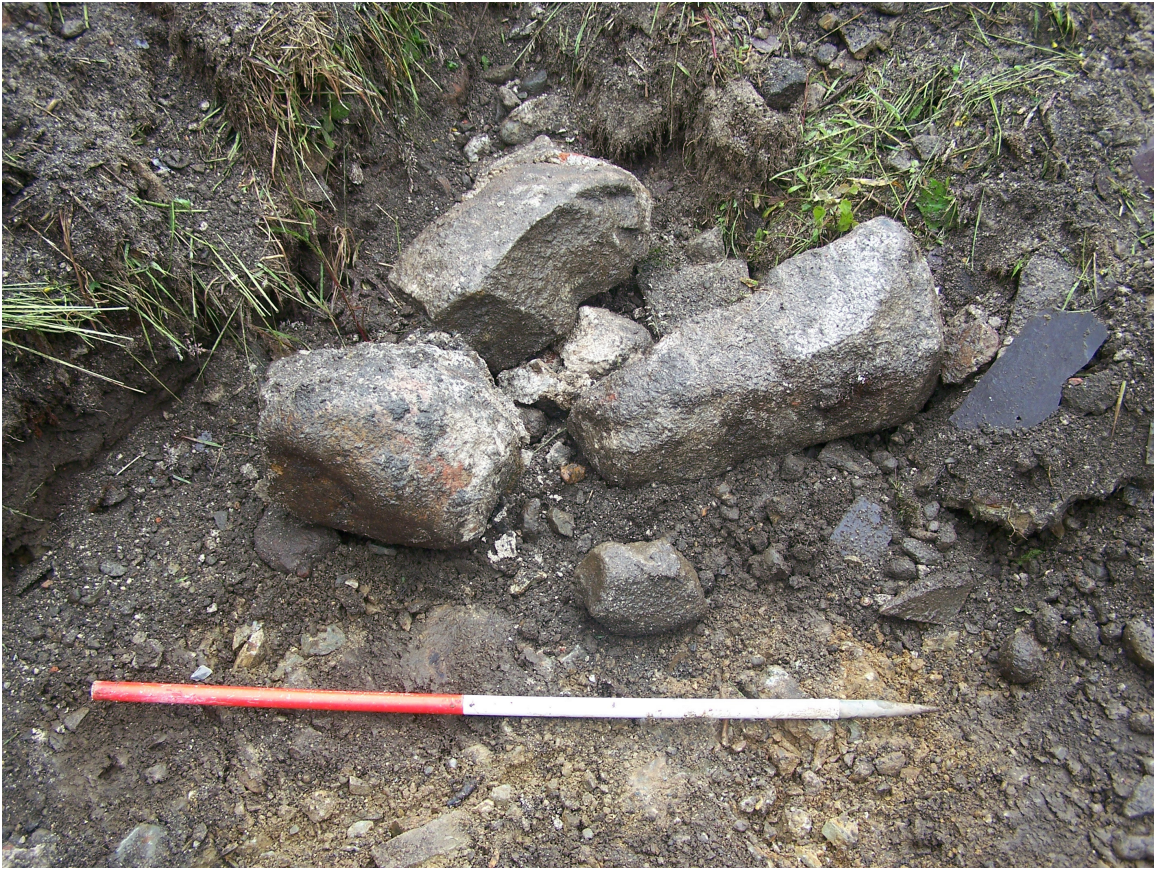
(Context No. 101) consisted of small to large angular and sub-angular stones and rocks (average size: 200mm x 150mm x 180mm) (Plate Three), whole bricks and brick fragments, bottle glass, plastic, metal and discrete spreads of mortar. This deposit (Context No. 101) lay directly on the surface of the subsoil and it was evident no other stratigraphic relationships were present on site. The mixed rubble deposit (Context No. 101) was generally homogenous and was on average 0.3m deep.

Plate Three: Large angular elements of mixed rubble deposit (Context No. 101).

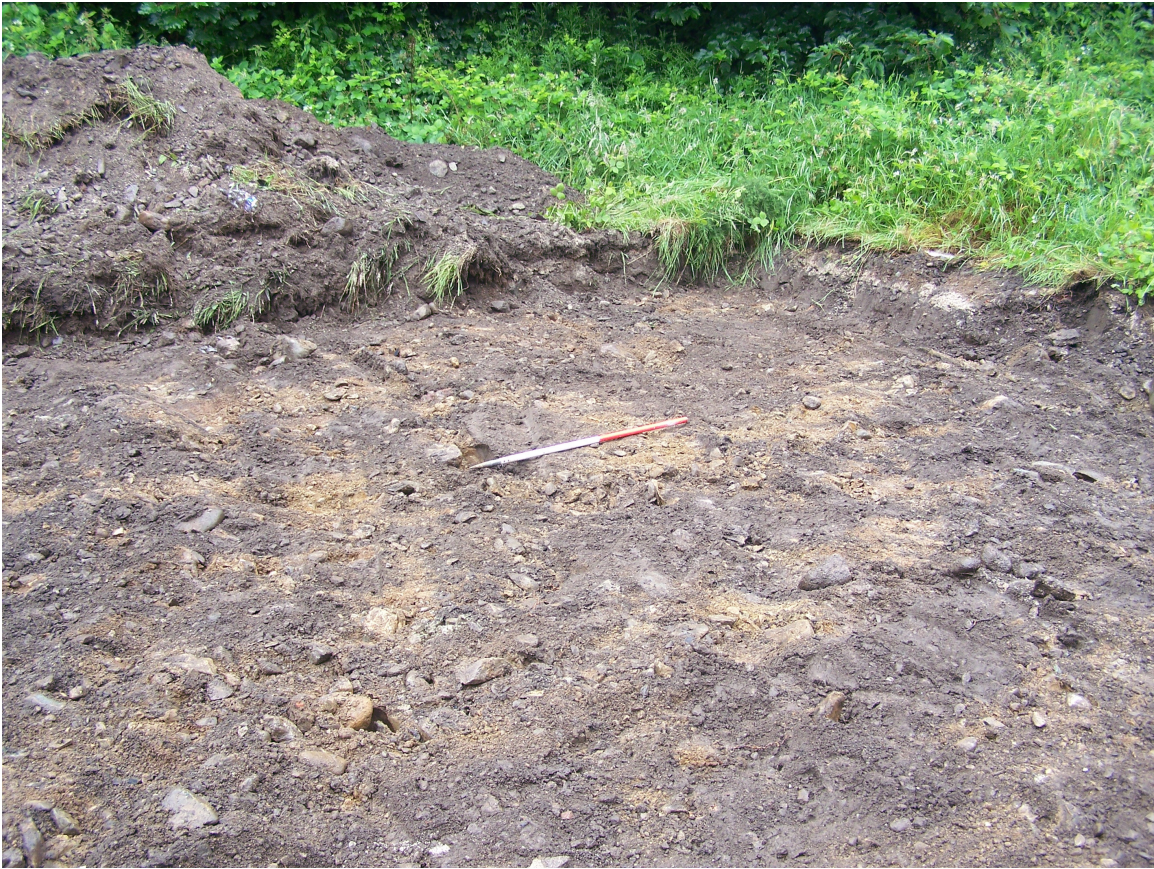
The mixed rubble deposit (Context No. 101) directly overlay the surface of the natural subsoil (Context No. 102). The natural subsoil (Context No. 102) consisted of a orange yellow gritty sand clay (Plate Four). Following the dumping of the mixed rubble deposit (Context No. 101), heavy plant machinery was driven over the site, pushing the larger elements of the rubble deposit into the surface of the subsoil. The result of this process was a severely truncated subsoil surface, and is likely to have destroyed any archaeological features that may have been present in the application area.

Plate Four: Application site following excavation to the surface of the truncated subsoil (Context No. 102), looking east.

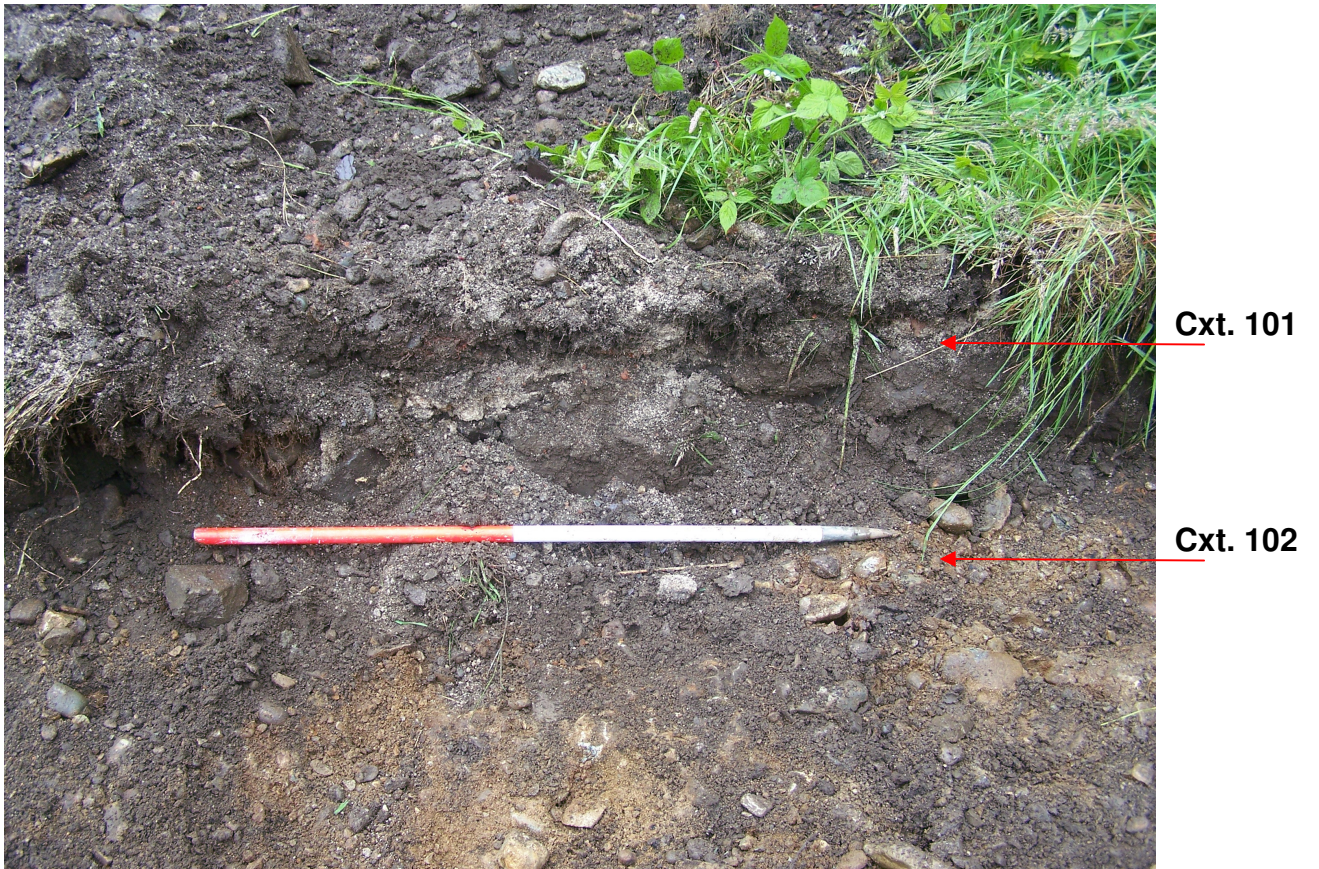
The area topsoil stripped measured approximately 12m (north/south) by 14m (east/west) and was undertaken mechanically. A simple stratigraphic sequence was encountered in the monitoring exercise, with the mixed rubble deposit (Context No. 101) lying directly on the surface of the subsoil (Context No. 102) (Plate Five). The mixed rubble deposit

Plate Five: East facing section of application site showing mixed rubble deposit (Context No. 101) directly overlying the natural subsoil (Context No. 102).
