## **Monitoring Report No. 193**

**St. Mary's Church Hall  
Macosquin  
Co. Antrim.**

**AE/09/161**

# Archaeological Monitoring at St Mary's Church Hall, Macosquin, Co. Londonderry

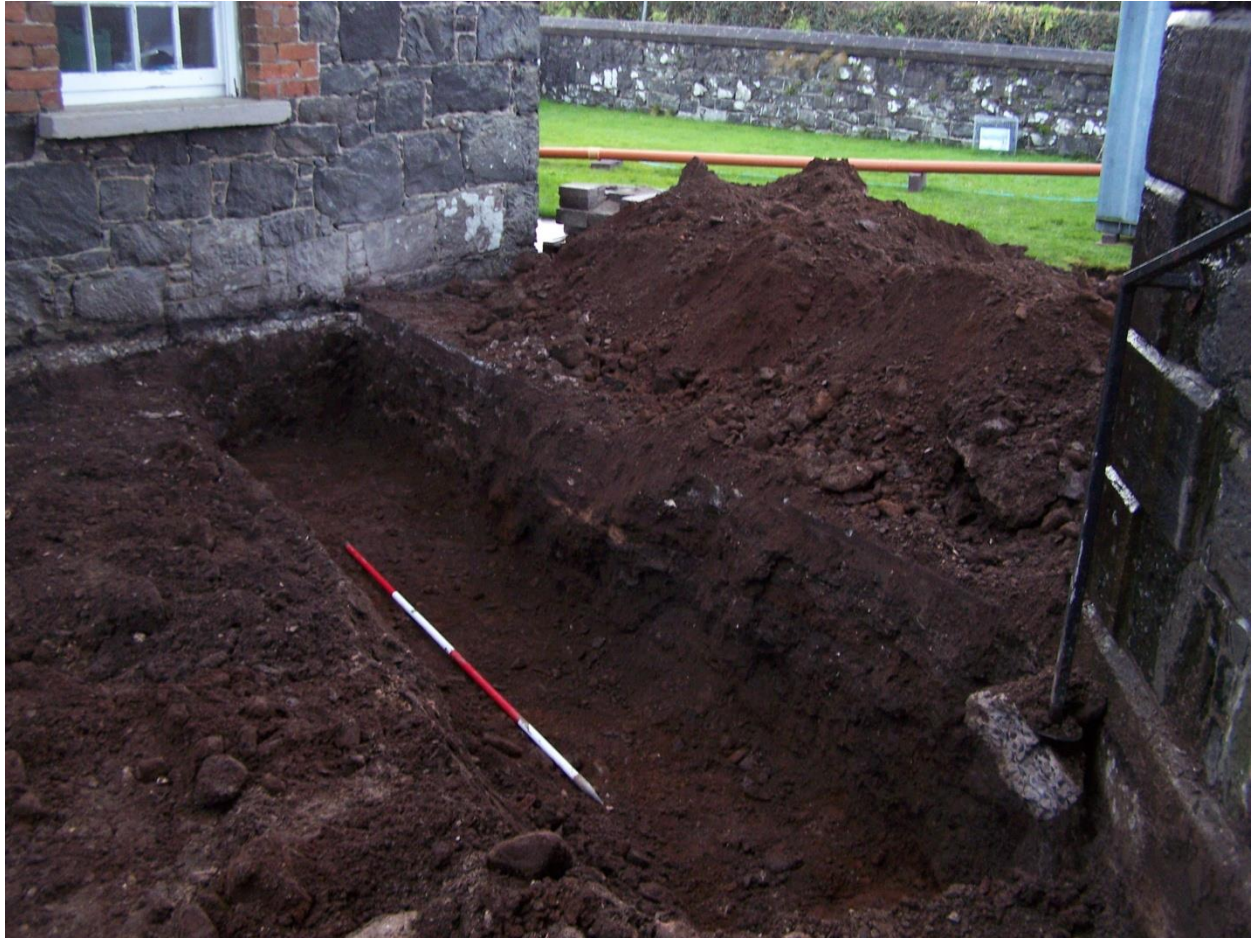
Area 1. Excavation of the west wall foundation trench in this area revealed the tarmac of the church carpark directly overlaying loam and sand layers, probably bedding layers for the tarmac. These layers were immediately above the natural subsoil. No archaeological finds or features were uncovered (Photo 1).

Photo 1: Foundation trench of west wall of porch (Area 1) showing tarmac bedding layers and natural subsoil.

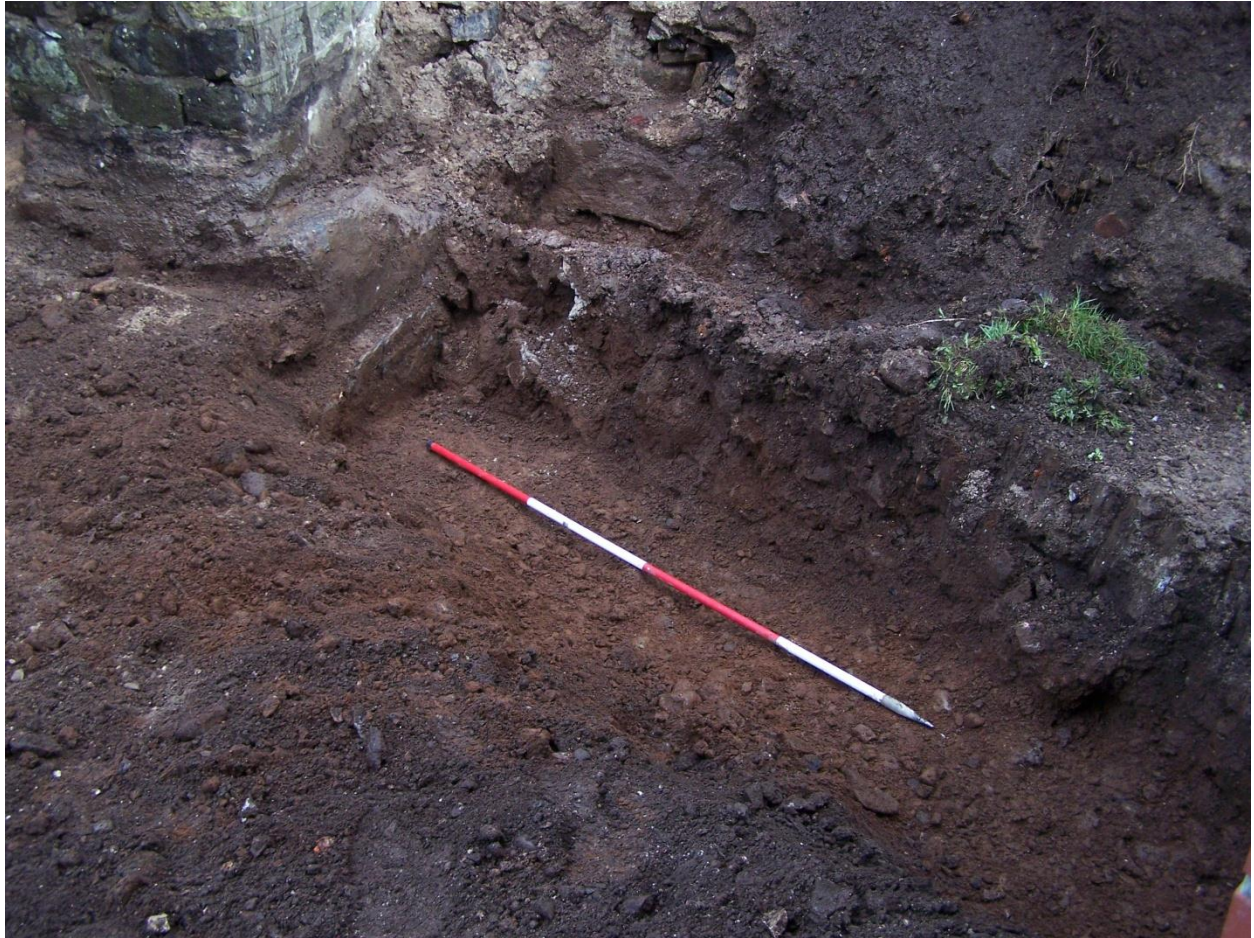
Area 2. In this area excavation of the new east wall foundation trench showed a mixed loam layer immediately above the subsoil. No archaeological finds or features were found (Photo 2).

Photo 2: Foundation for east wall of porch (Area 2) after excavation, showing location of removed retaining wall (Area 3) in background.

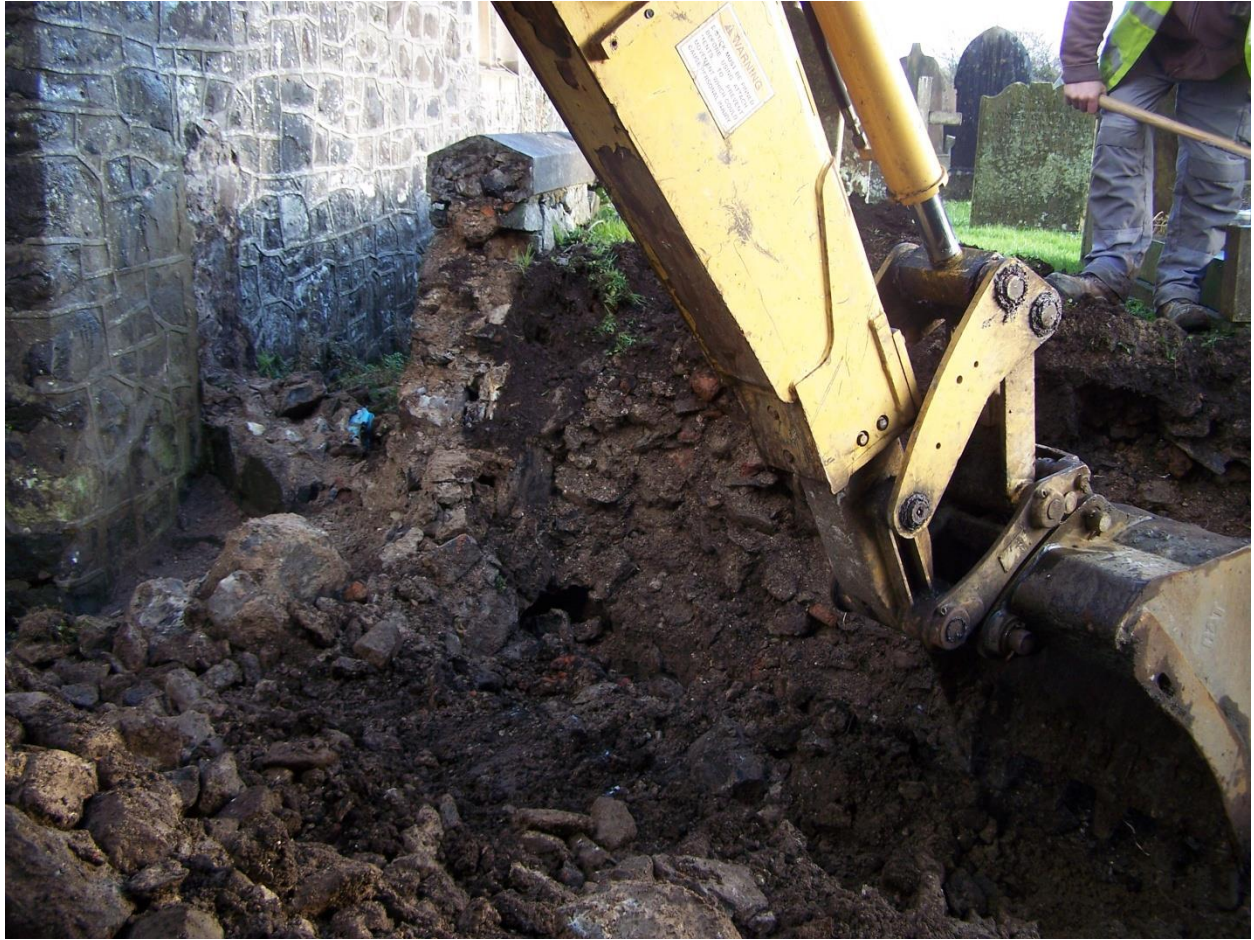
Area 3. This retaining wall was removed by mechanical excavator under archaeological supervision. No artefacts or features were disturbed by this work (Photo 2 and 3).

Photo 3: Removal of retaining wall (Area 3) to west of graveyard by mechanical excavator.

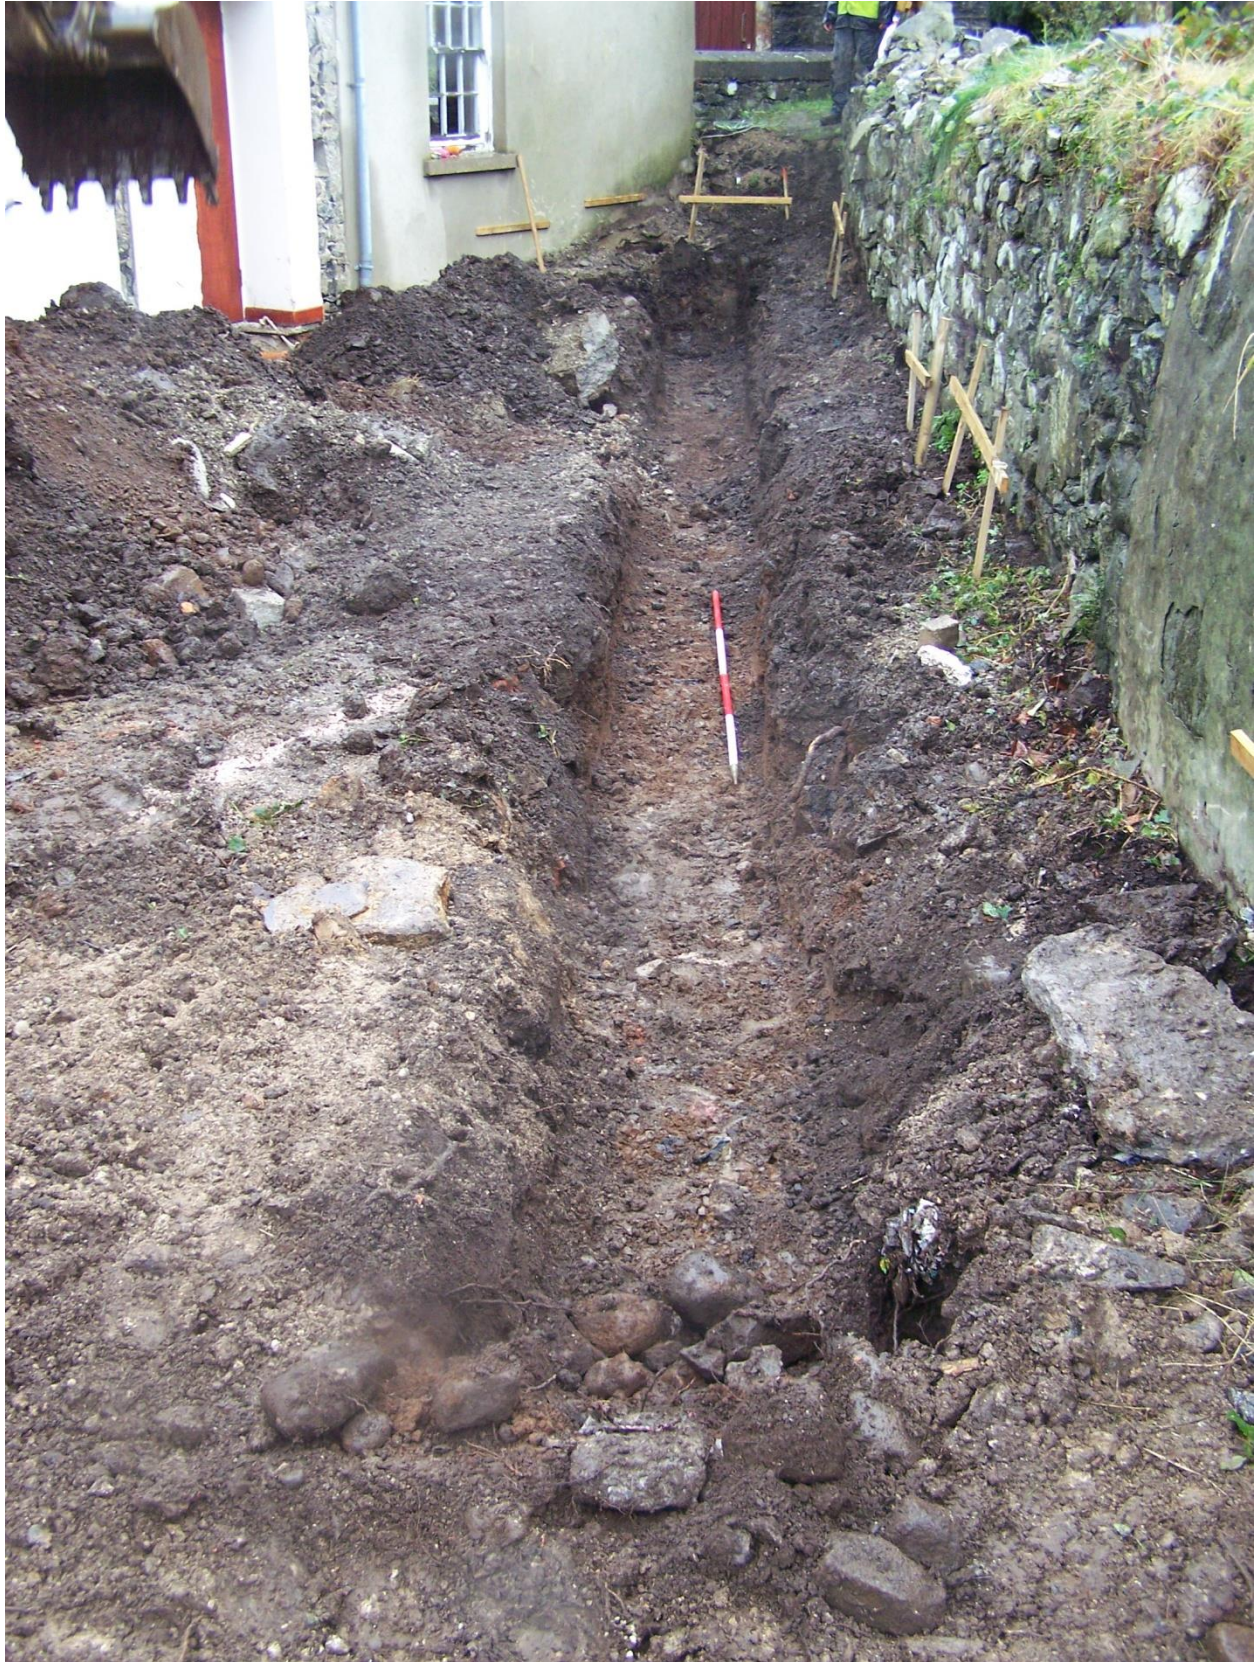
Area 4. In this area excavation of the foundation trench for the east wall of the toilet block and kitchen extension, revealed a layer of loam and mid 20<sup>th</sup> century building materials, directly overlaying the natural subsoil. There was no indication of archaeological artefacts or features (Photo 4).

Photo 4: Area 4 showing foundation trench for east wall of kitchen block / toilet extension.
