EVALUATION REPORT No. 273

Freeduff Presbyterian Church,
3 Oldtown road, Freeduff,
Cullyhanna, County Armagh

Licence No.: AE/13/133E

Report Date: 20/09/2013

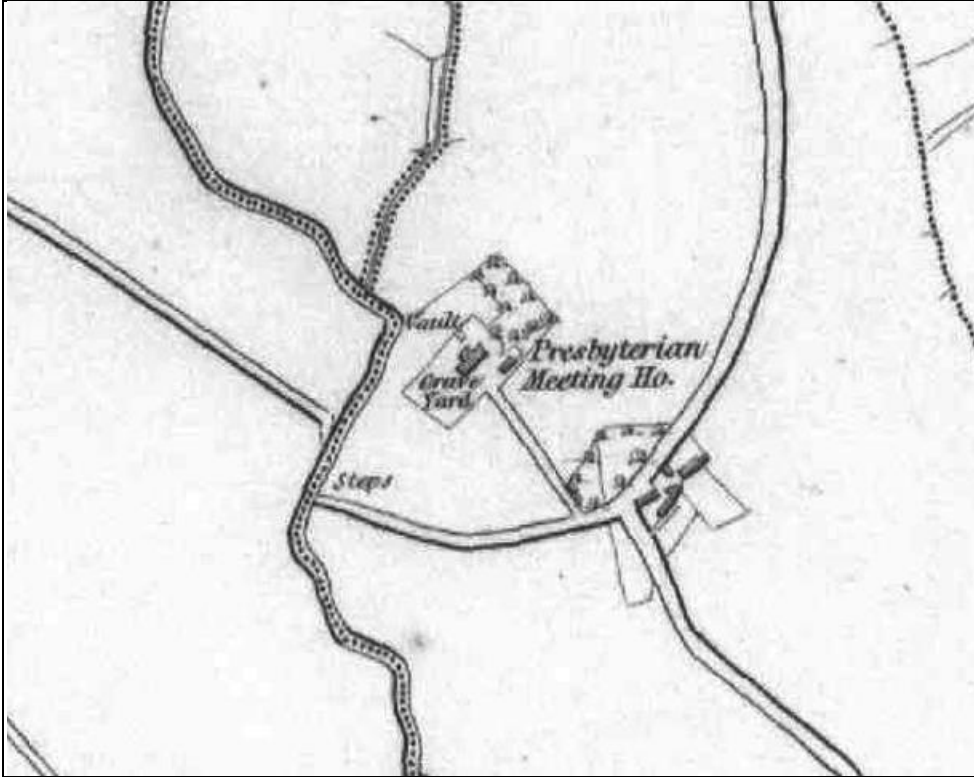
Figure 3: Six Inch, First edition County Series map (1829-1835), showing a 'vault' marked in an adjacent location to the development area (NIEA LPS, 2006)

A 'vault', most likely a burial vault, is depicted on the First edition County Series map of 1829-1835, immediately adjacent to the development area (figure 3). There is currently no visible evidence of a vault at this location which is now occupied by marked graves.

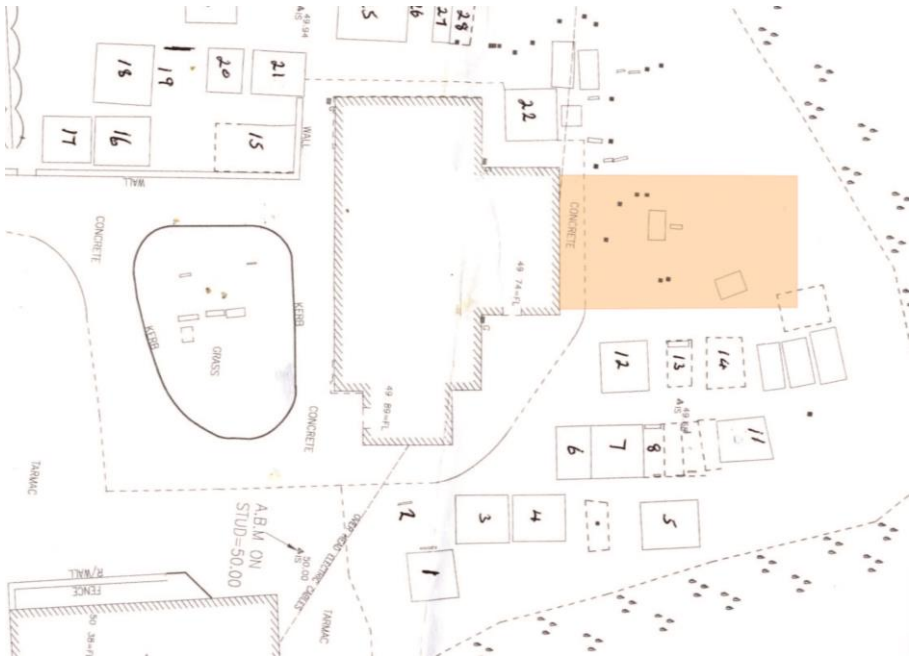
Figure 4: (Undated) plan of marked graves, as provided by Rev. Brian Wilson of Freeduff Church; The area of the proposed new development is highlighted.

location of grave markers shown in figure 4, that the edge of a burial may be encountered, however no evidence of an undisturbed grave cut or coffin was observed.

It is highly likely that the sinking of the foundations of the proposed new extension will disturb further human remains. This is evidenced by the presence of at least 13 graves in this area, as indicated on the undated plan provided by the church minister, Reverend Brian Wilson (figure 4). The excavation of the seven evaluative trenches confirms the presence of intact burials at these marked locations, and, given the location of the skeleton found in Trench 7, shows that there are also burials in unknown locations. It is likely that the grave-markers for the latter were removed prior to drafting of the grave plan given in figure 4. It is estimated that the majority of currently unmarked burials are contained within the half of the development area which is closest to the upstanding church. In conclusion, it is evident that human burials will be disturbed by ground-works at the site and mitigation will need to be undertaken to either remove and re-bury the remains or make alterations to the architect's plans. Further works at the site will be decided by the developer in conjunction with the NIEA Inspector for the area and the Planning Service.

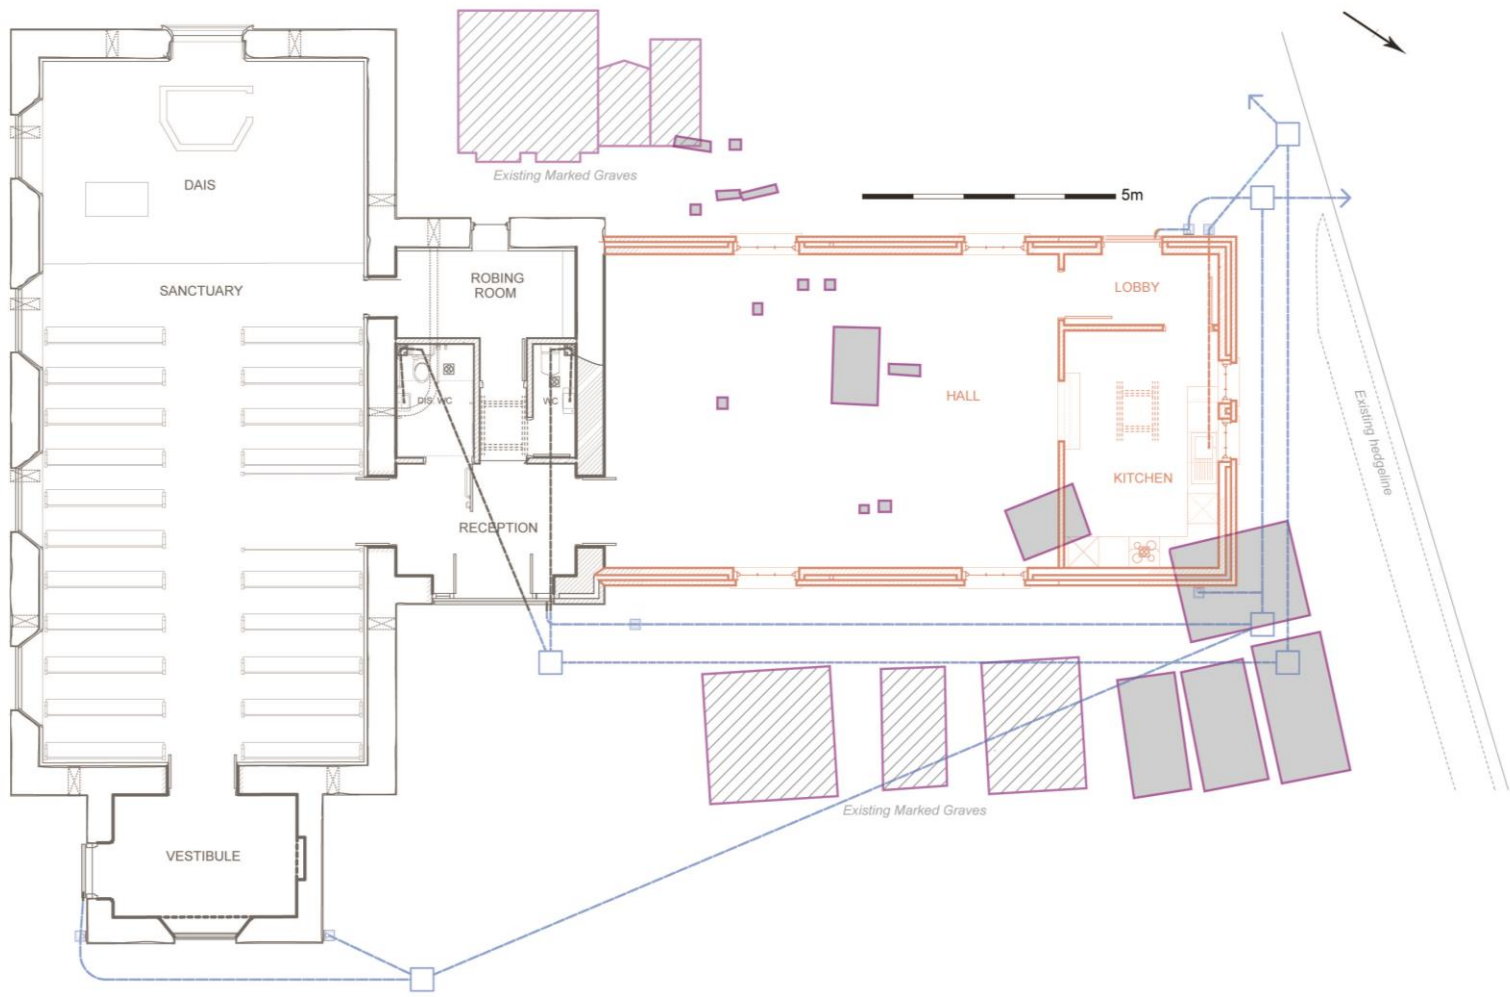
Figure 5: (Based on the architect's plan supplied by Chris McCollum, Building Conservation Surveyor); Plan of the upstanding church with the walls of the proposed new extension (red), lines of new drainage/water courses (blue), currently visible marked grave-plots (hatched boxes), and grave plots which are no longer marked/visible (shaded grey boxes).

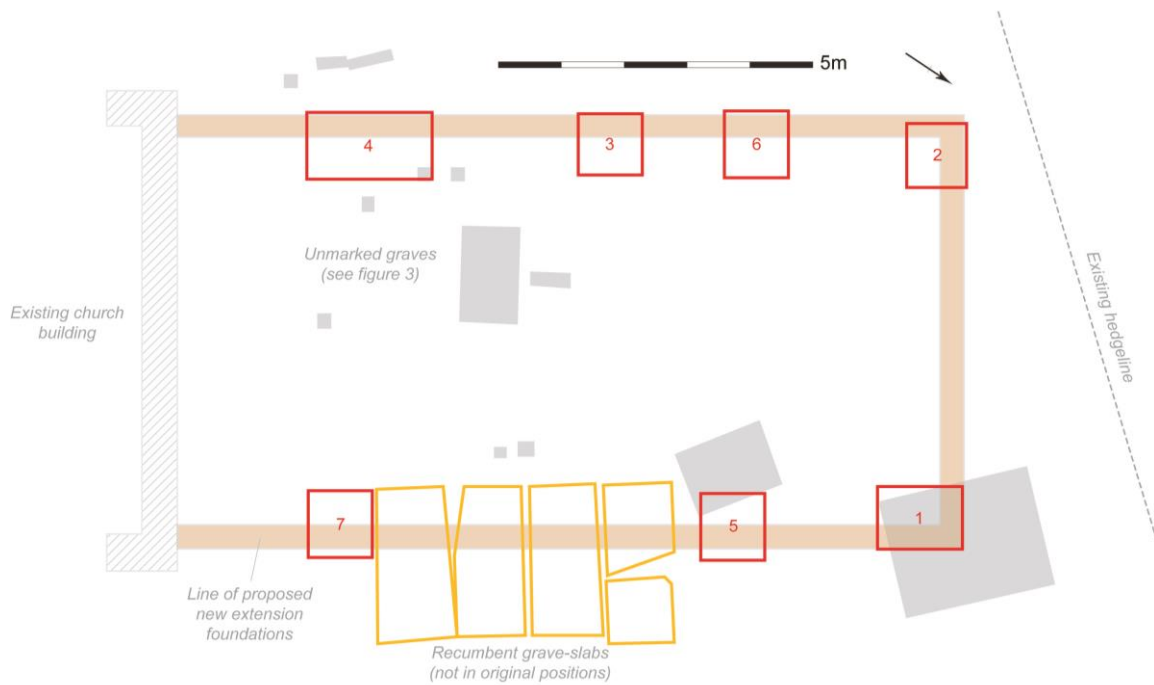
Figure 6: Plan showing locations of excavated trenches (red), grave slabs lying within development area (yellow), and graves which are shown on the grave plan given in figure 3 but are now unmarked and not visible on the ground surface (grey)

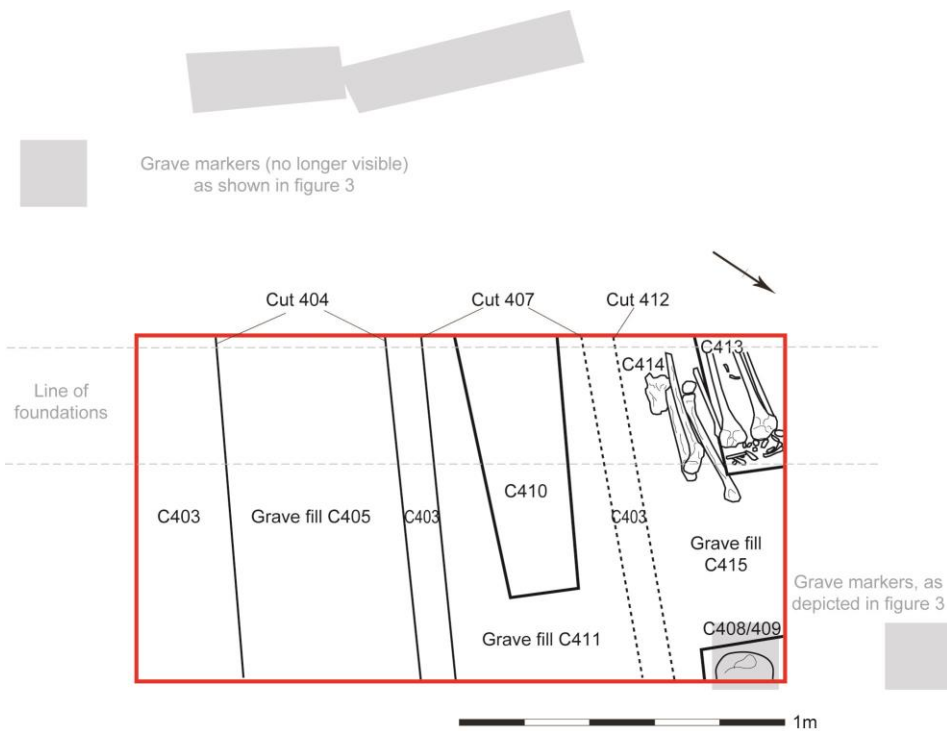
Figure 7: Plan of trench 4, showing location of grave cuts, coffins and skeletal remains. Note the positions of the grave markers (as shown in figure 3), corresponding with the excavated graves and remains.

Trench 4 was located along the western limit of the development area, close to the church wall and was entirely hand-excavated. Initially the trench measured 1m x 1m but was then extended to 2m x 1m due to the high probability that skeletal remains would be discovered as indicated by a grave plan of the site (figure 4). It was thought that a 1m x 1m trench would not be sufficient to fully investigate this (figure 7).

Articulated skeletal remains with associated coffins and grave cuts were uncovered at a depth of 0.35-0.40m in the northwestern half of the trench. The articulated lower remains of one individual were found within the outline of a narrow coffin (C413), disappearing into the trench section at the westernmost corner. Alongside this were disarticulated long-bones (C414), probably from one other individual. These appeared to have been carefully laid alongside the coffin and along the same alignment. Directly overlying the coffin burial and long-bones and within the layer C406, a concentration of disarticulated human skeletal remains was found. These were removed in order to expose the extent of the articulated remains beneath. The top edge of a second coffin and intact skull (C408/409) were uncovered at the northernmost corner of the trench. Individual grave cuts were not identified for these two coffins and associated long-bones, however the faint edge of a grave cut separating them from other burials within the trench, could be made out, to the southeast (C412). The

outline of a third coffin (C410) was exposed approximately 0.4m to the southeast of the first coffin (C413), and contained extremely delicate and fragmented human remains which could be only faintly discerned from the associated grave soil (C411). The edge of a grave cut (C407), associated with this burial, could be seen approximately 0.12m from its southeastern edge. Another linear cut, C404 was observed a further 0.12m southeast of C407, and was filled with mottled brown, slightly gravelly clay (C405), similar to the fills of the other grave-cuts. No evidence of a coffin or articulated human remains could be seen in the surface of this layer.

The skeletal remains, coffins and grave-cuts were all aligned northeast-southwest, with their heads to the southwest. The remains in this trench were exposed at depths of 0.35m and 0.40m, at the southeastern and northwestern ends respectively, cleaned up, measured and photographically recorded. No further remains were removed and tarpaulin was placed over the exposed remains prior to back-filling of the trench.

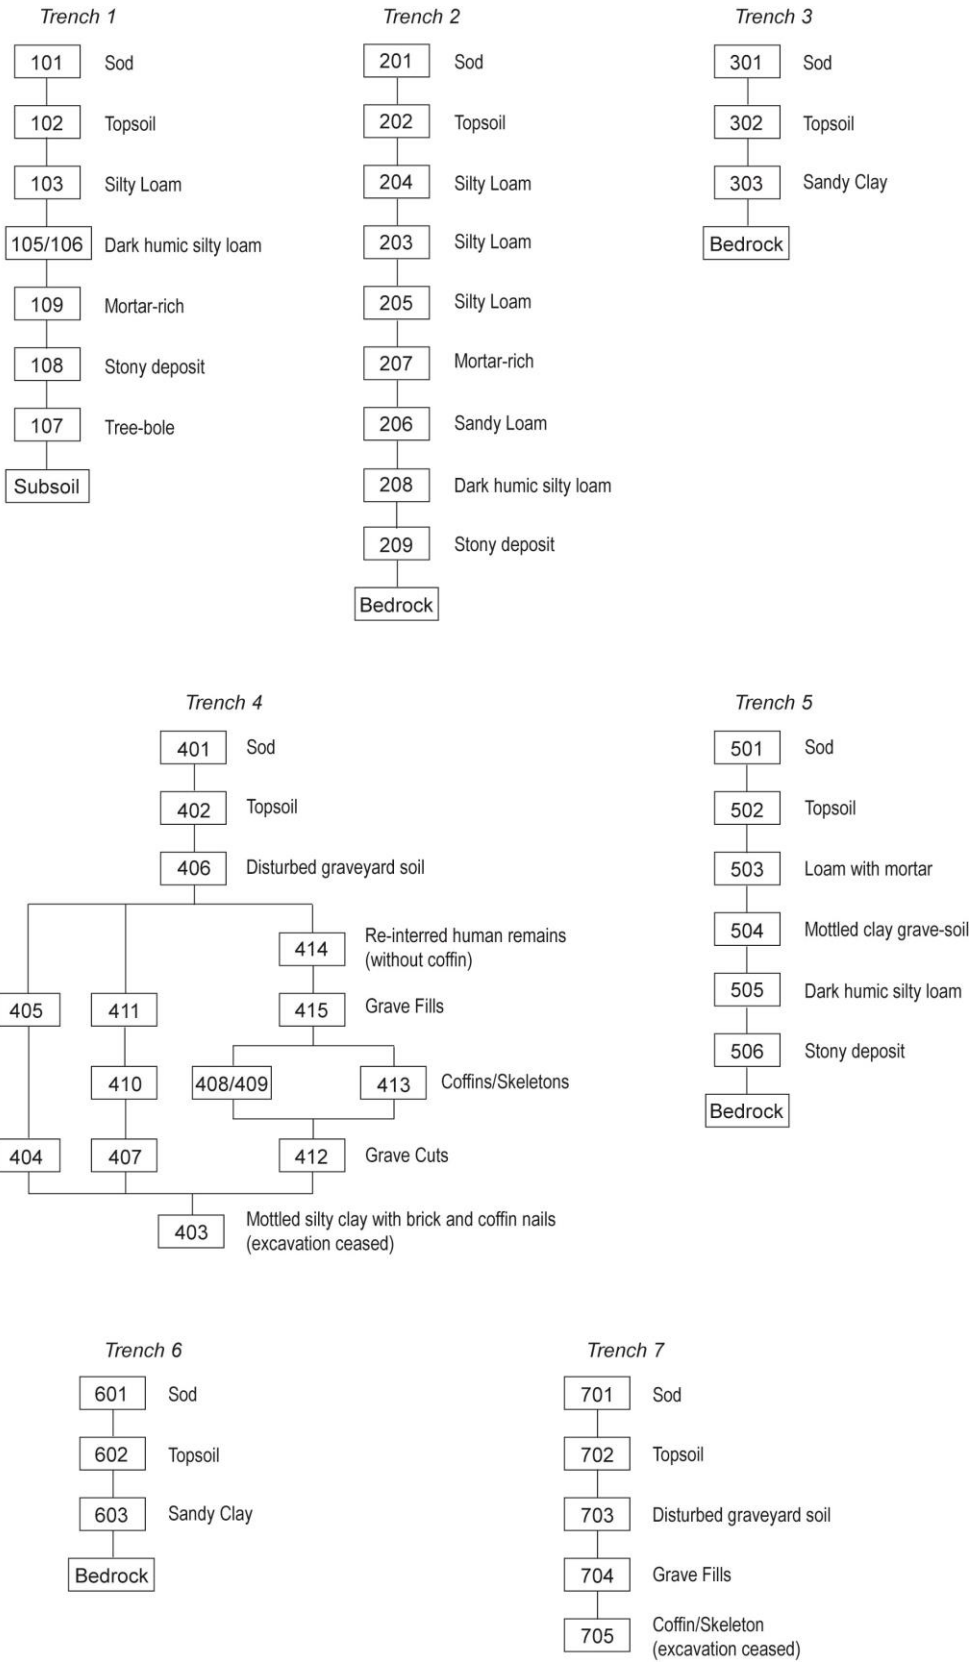
Figure 8: Harris matrices for all excavated trenches

A total of seven trenches were opened up within the footprint of the walls for the proposed new extension. Initially, five 1m x 1m trenches were opened and excavated by hand. One of these was then extended, by hand, to become a 2m x 1m trench and two further 1mx1m trenches were excavated mechanically once the hand-excavated trenches had reached a stage of completion. The matrices for the excavated trenches have been included in this report and it is intended that they are referred to while reading the following account of the excavation (figure 8)

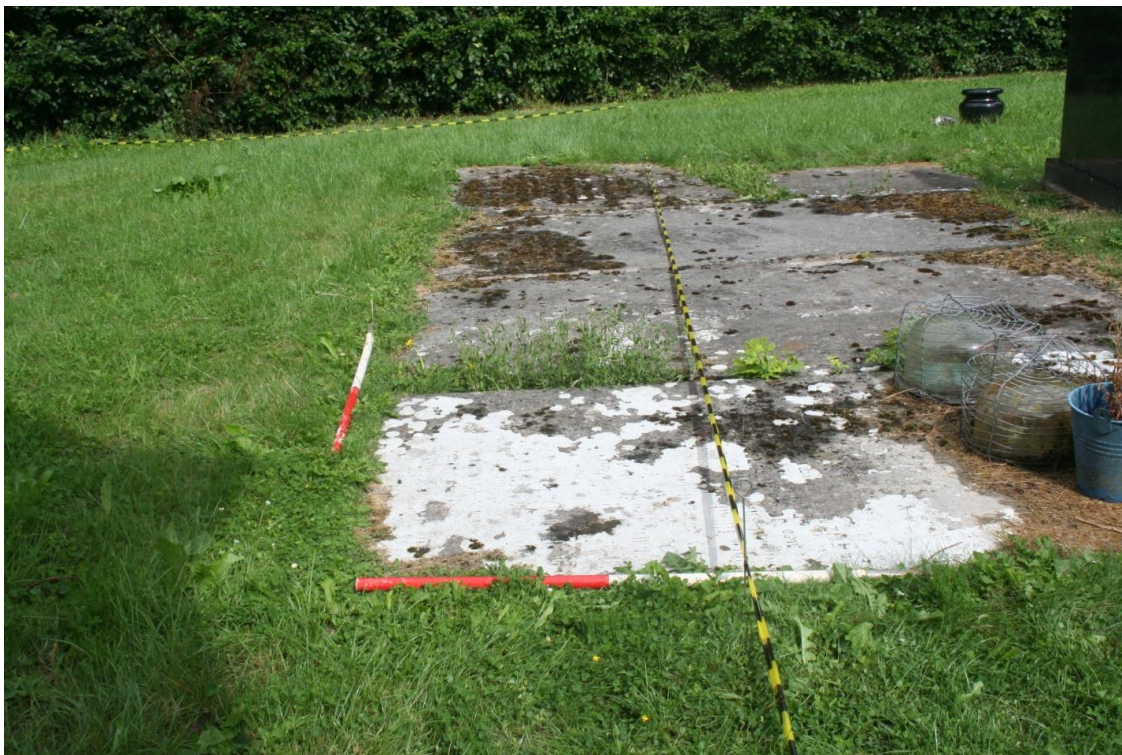
Plate 4: 'Tidied-up' grave-slabs lying across the line of planned foundations, looking NNW

Freeduff church is aligned on an east-northeast – west-southwest axis and is surrounded by a poured-concrete pathway. The new proposed extension runs in a northwesterly direction from the church's northwestern façade and encompasses a rectangular area measuring 12.42m by 6.85m. The development site occupies a raised, fairly flat and uniform area which slopes down towards a planted hedgerow along its northwestern edge. Marked grave plots are visible on the ground surface immediately to the west and east of the development area. Five large grave slabs dating to the 19th century were found lying across the location of one of the proposed new extension walls. These, however, have been reported, by the church minister, to have been placed here in recent years during a 'tidy-up' of the graveyard and indeed, on further inspection, it is evident that they are not in their original placements. One of the grave slabs which at first glance, appeared to be broken in two was in fact from two separate burial plots. Further grave slabs have been laid side by side in the same manner, and presumably at the same date, along the western edge of the existing graveyard. The

original locations of these grave slabs are unknown and cannot be determined without the aid of a detailed grave plan showing their original placements. No further indications of grave markers or plots were visible on the ground surface within the proposed development area.

It is probable that the burials encountered during excavations date from the 18th - 19th century. It may be further suggested that the slabs found 'tidied-up' in various locations may once have served as some of their respective grave-markers.

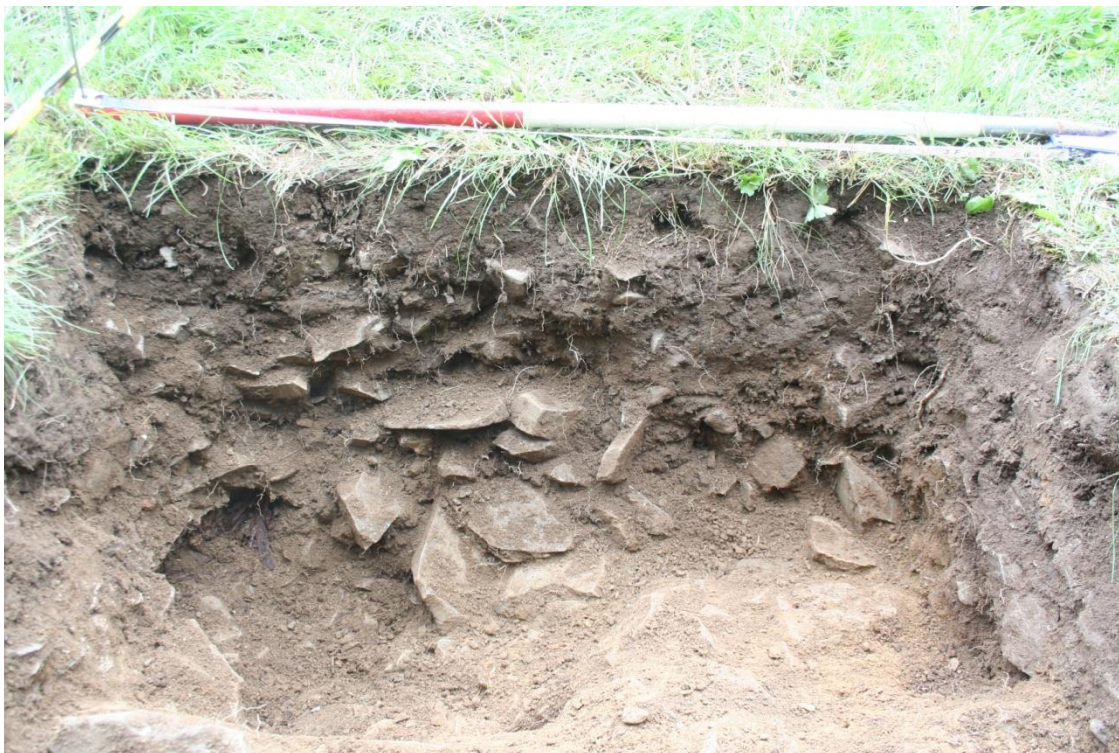
Plate 7: Trench 1, post-excavation, ENE facing section showing C108, 106, 103, 102, 101, looking WSW

This comprised a 1m x 1m trench located in the northernmost corner of the development area. Manual excavation of this trench revealed successive layers of loamy leveling soils (C103, 106, 109) and basal deposit of stony rubble (C108), beneath the sod (C101), and topsoil (C102). Artefact material of 19th - 20th century date was uncovered including, glass, brick, plastic, slate, stoneware, and various broken ceramics. A single fragment of disarticulated human skull and five coffin nails were found in the upper layers of the trench alongside 19th-20th century debris and various parts of plastic, fabric, and metal grave tributes. A thin mortar-rich layer (C109) was also observed in the northeastern half of the trench. The basal layer (C108) came directly down onto an uneven surface of orange silty clay subsoil with voids caused by decayed roots. The voids left by the roots were up to 0.1m in diameter and it is likely that the uneven base of trench 1 was created by the removal or decay of a fairly large tree. During the final stage of the evaluation the trench was deepened using the mechanical excavator which confirmed that the orange silty clay encountered at a depth of approximately 0.5m, was natural subsoil.

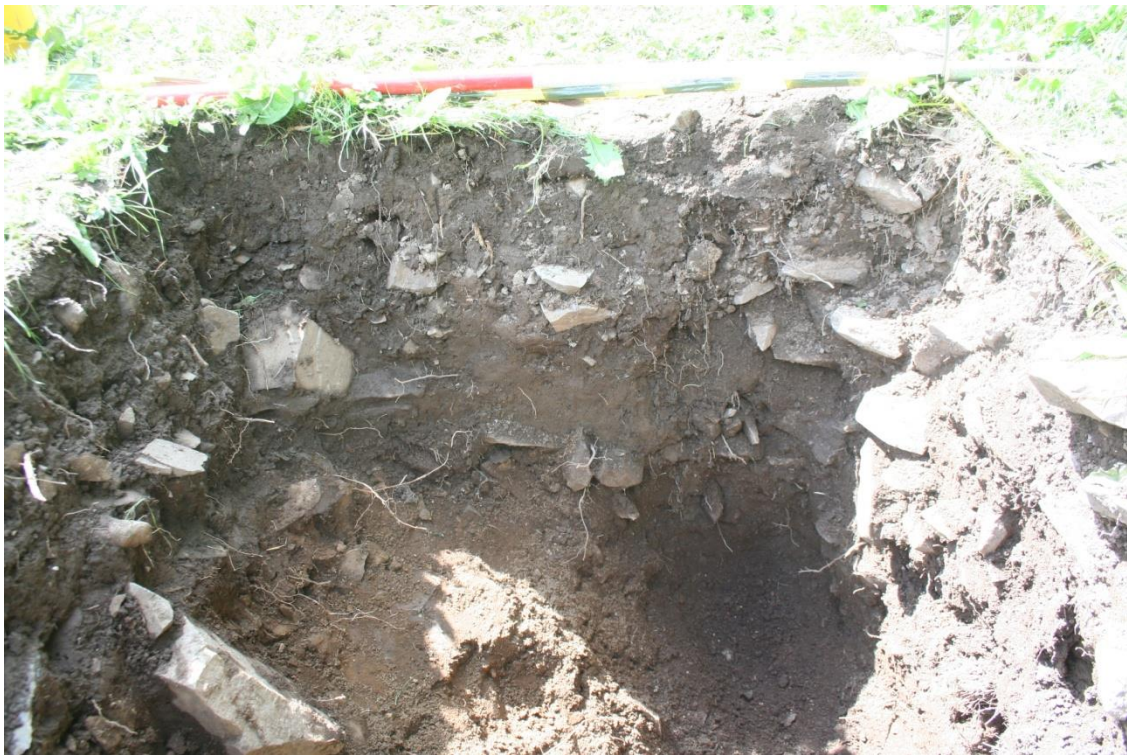
Plate 10: Trench 2, ENE facing section post removal of C208 & 209, looking WSW

This was initially a hand-excavated trench, 1m x 1m in size and positioned at the western corner of the development area, at the edge of the leveled ground where it sloped sharply towards the planted hedgerow. As with trench 1 it was found to contain layers of stony rubble (C209), loamy leveling soils (C203, 204, 205), mortar (C207), and 19th - 20th century artefact material, including glass, various plastics, painted concrete render and broken ceramics. A fragment of a large clay pipe bowl with a hatched heart striking surface, was recovered from an upper silty loam layer (C203). A broken end-scraper, which could potentially be of Bronze Age date was found in a sandy layer which also contained modern finds of concrete, glass, plastic and iron guttering (C206). The basal layer within the trench was a thick deposit of angular stones (C209), very similar to the stony deposit in trench 1 (C108). Overlying this, in the northeastern half of the trench, was a thick humic deposit (C208), of similar consistency to garden compost. A single broken slab of concrete was recovered from this layer. Due to the depth reached in this small trench, it was not possible to complete excavation by hand. Therefore, this was done using the mechanical excavator and the trench was excavated to the level of the shattered bedrock, which, due to the natural slope underlying the leveled upper surface, was encountered at a depth of 0.9m. No human bone or coffin nails were found in this trench and no further finds or features of archaeological interest were noted.

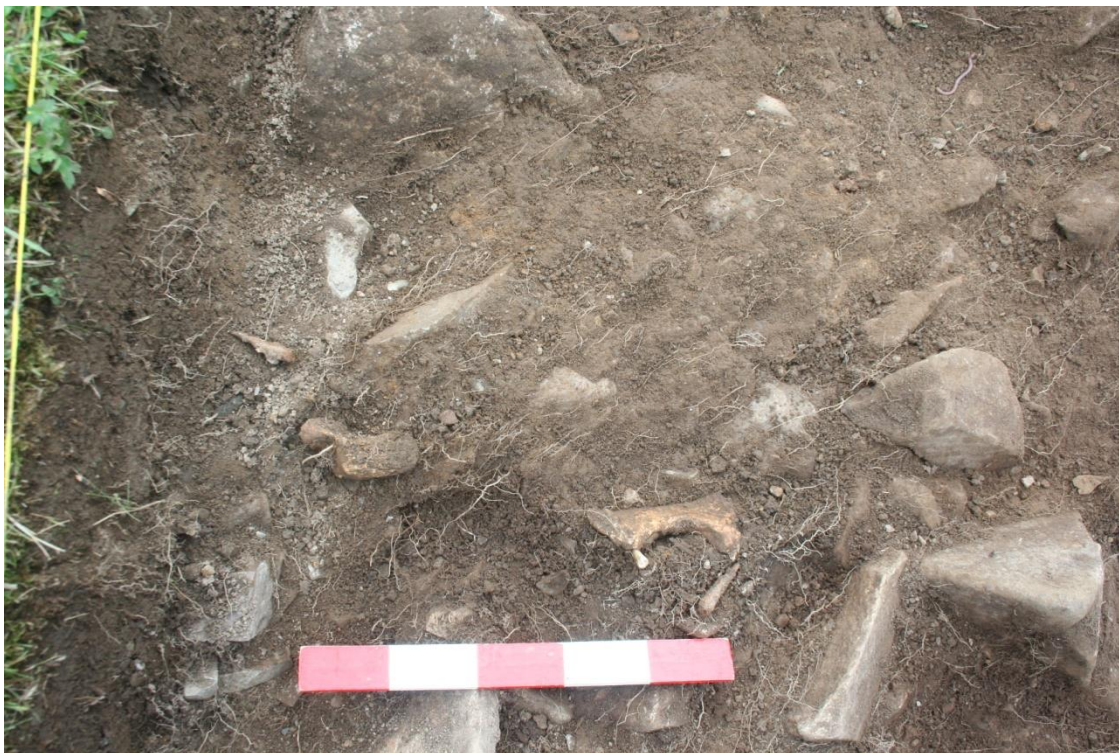
Plate 13: Trench 3, disarticulated human skull, bone, teeth and iron coffin nails, within C303, looking WSW

Trench 3 was located mid-way along the western limit of the proposed new extension and measured 1m x 1m. This trench was entirely hand-excavated and removal of the sod (C301) and topsoil (C302) layers revealed orange-brown compact sandy clay (C303) with sub-angular stones. Disarticulated fragments of a human cranium and mandible were recovered from this layer along with corroded iron coffin nails and plastic electrical tape. No evidence of articulated remains or cut features was observed

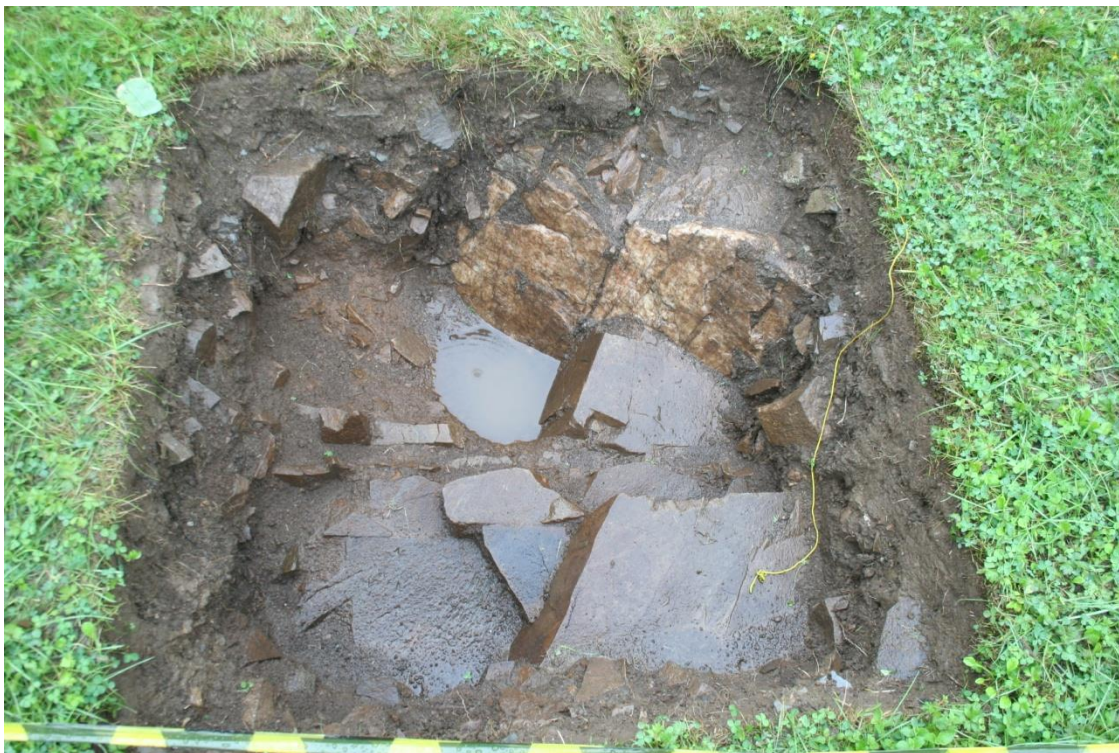
Plate 15: Trench 3, post-excitation view showing bedrock, close to ground surface, looking ENE

and removal of the sandy clay revealed the shattered bedrock of the site, fairly close to the surface, at a depth of 0.08 to 0.26m.

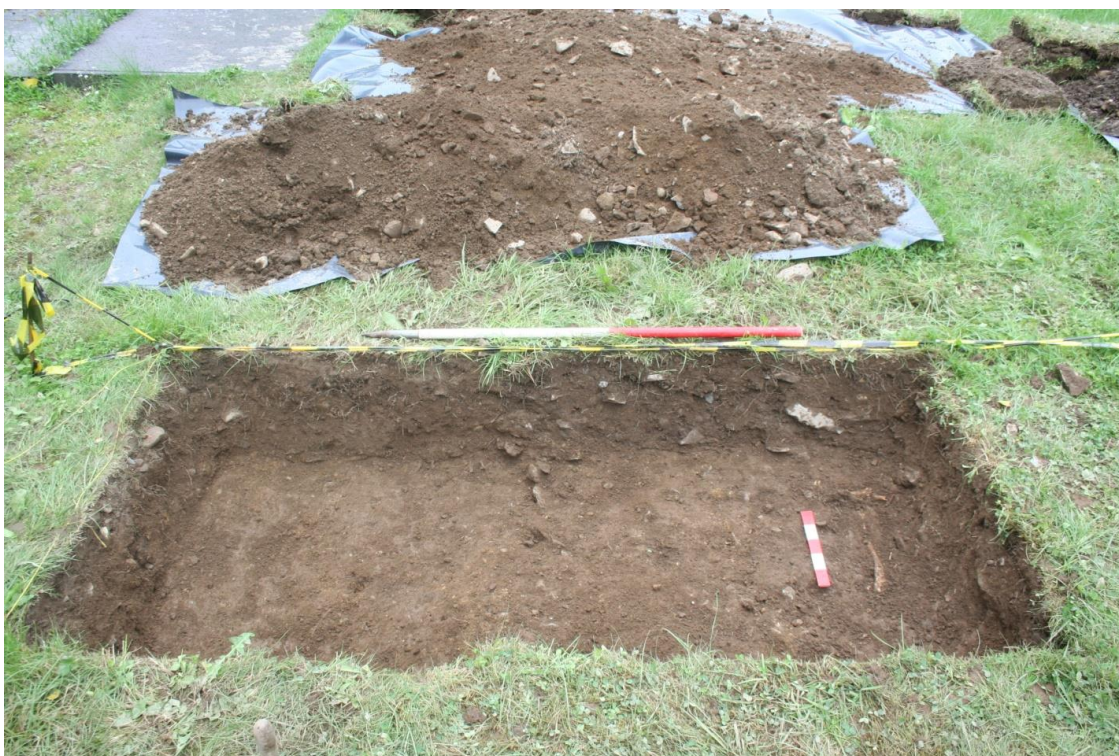
Plate 16: Trench 4, post removal C402, showing C406 with disarticulated human remains at NW end of trench, looking WSW

Removal of the sod (C401) and topsoil (C402) layers revealed a loamy layer of disturbed graveyard soils (C406) which contained iron coffin nails and fragmented and disarticulated human bone. Removal of C406 revealed a number of wide linear features (C404, 407, 412), at a depth of 0.35-0.40m, cut into a layer of mottled clay (C403). The cut features were filled with gravelly, compact graveyard-type soil which was not fully excavated as it became evident that both articulated and disarticulated human remains were present along with the remains of coffins, within these fills.

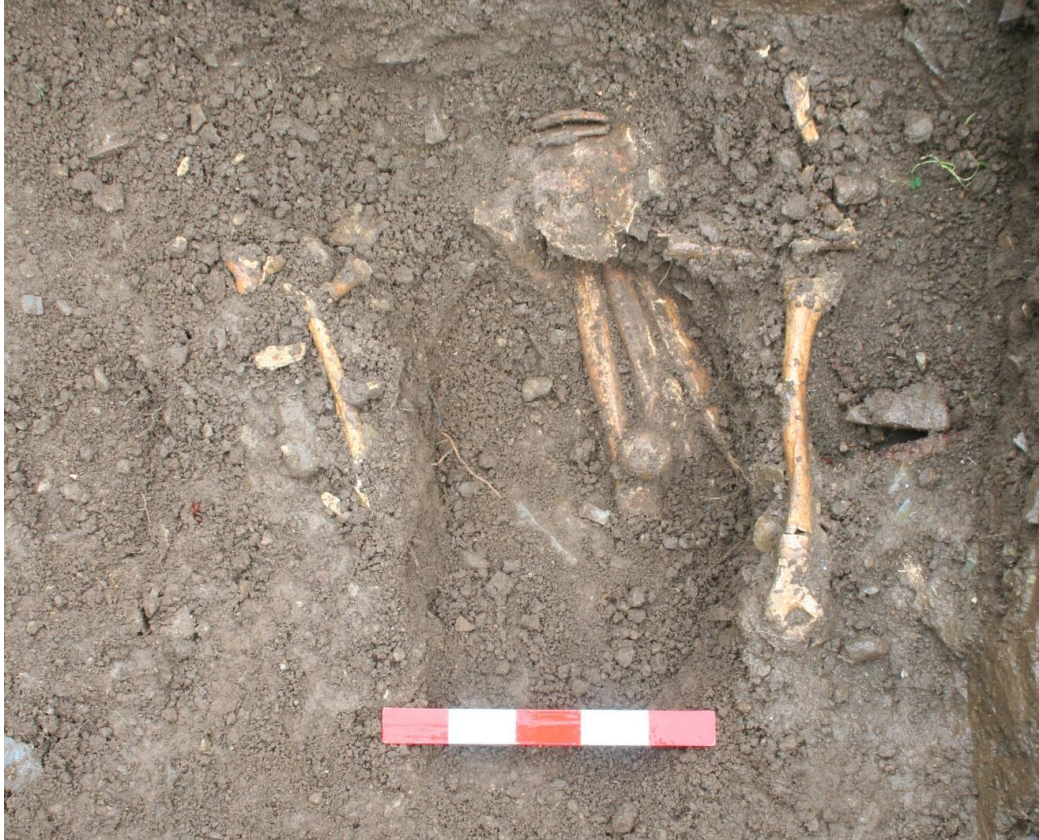
Plate 17: Trench 4, C406, mid-excavation, coffin C413 & long-bones C414 visible, looking WSW

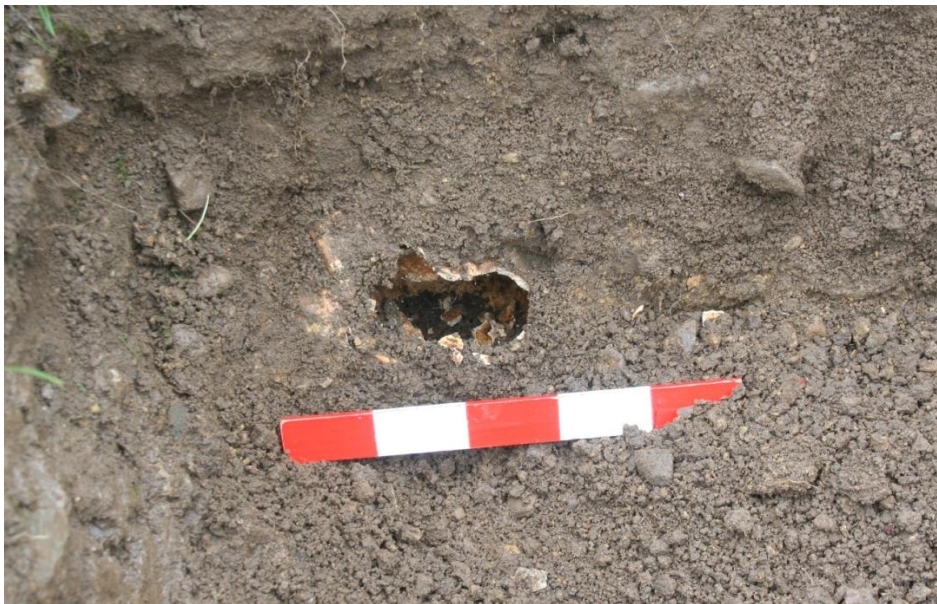
Plate 18: Trench 4, head of coffin C408, and skull C409, visible in WSW facing section, looking ENE

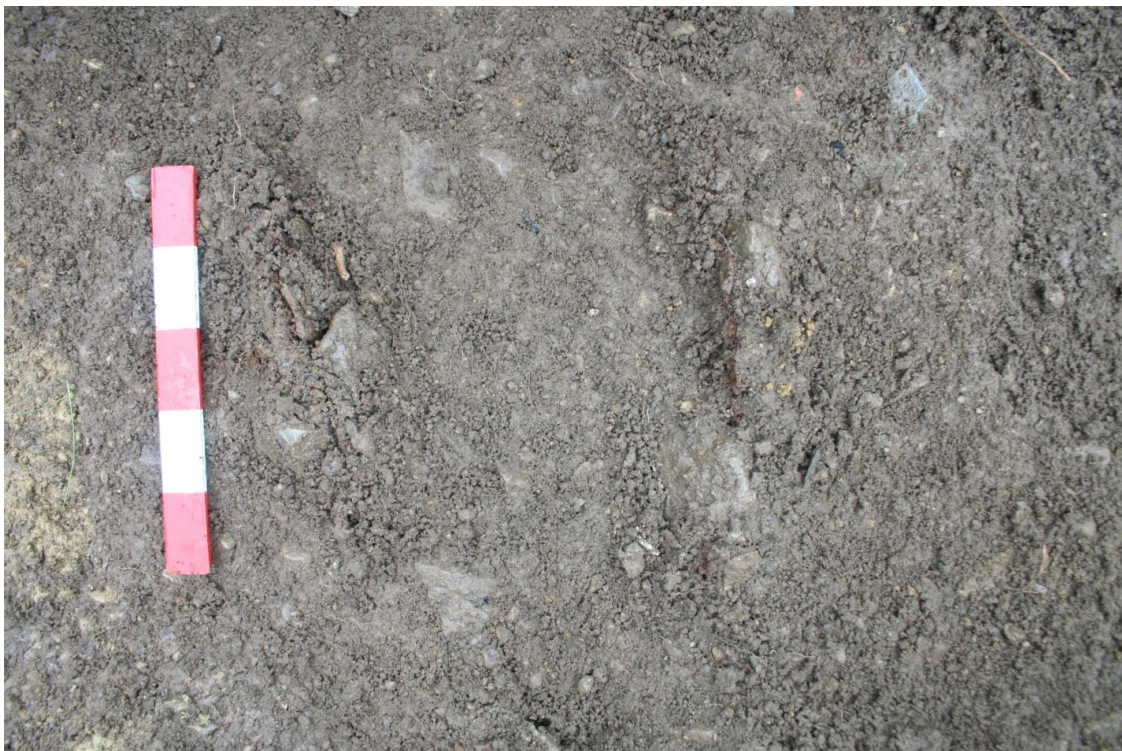
Plate 19: Trench 4, remains of coffin & skeleton C410, with associated grave cut C407 visible on right, looking WSW

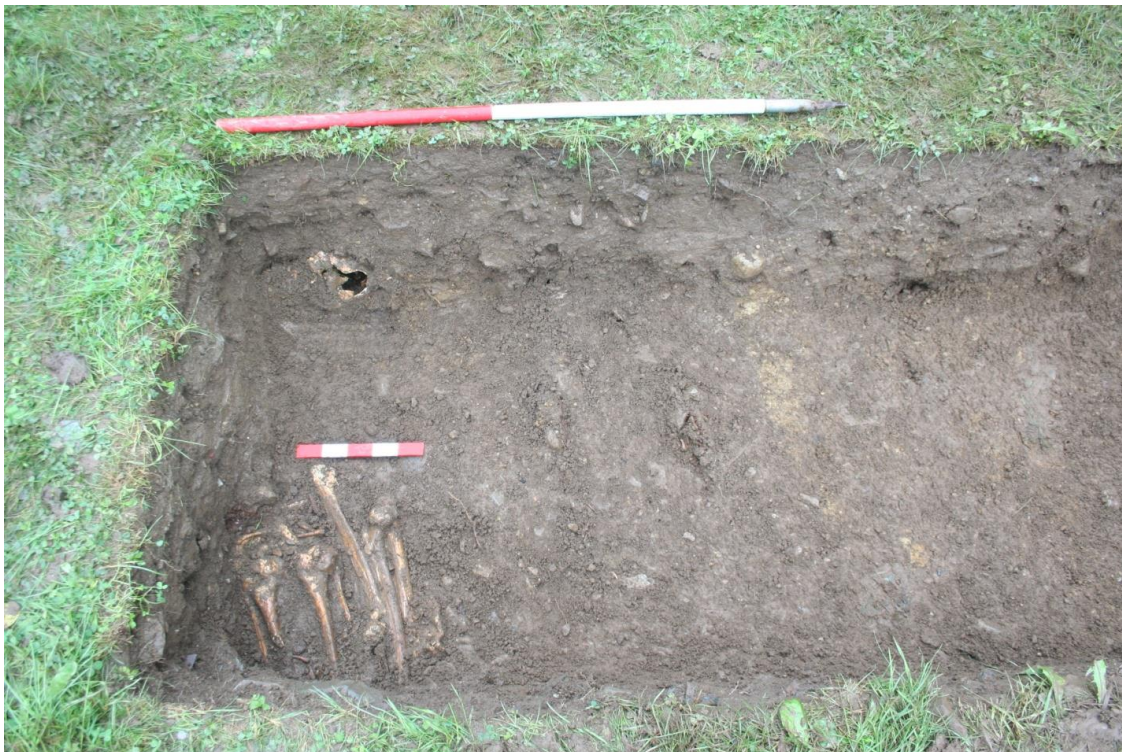
Plate 20: Trench 4, post-removal C406, showing grave cuts (L-R) C412 (faint), C407 & 404. Skull & coffin C408/409 visible on top left. Also showing skeletal/coffin remains (L-R); C413, 414 & 410.

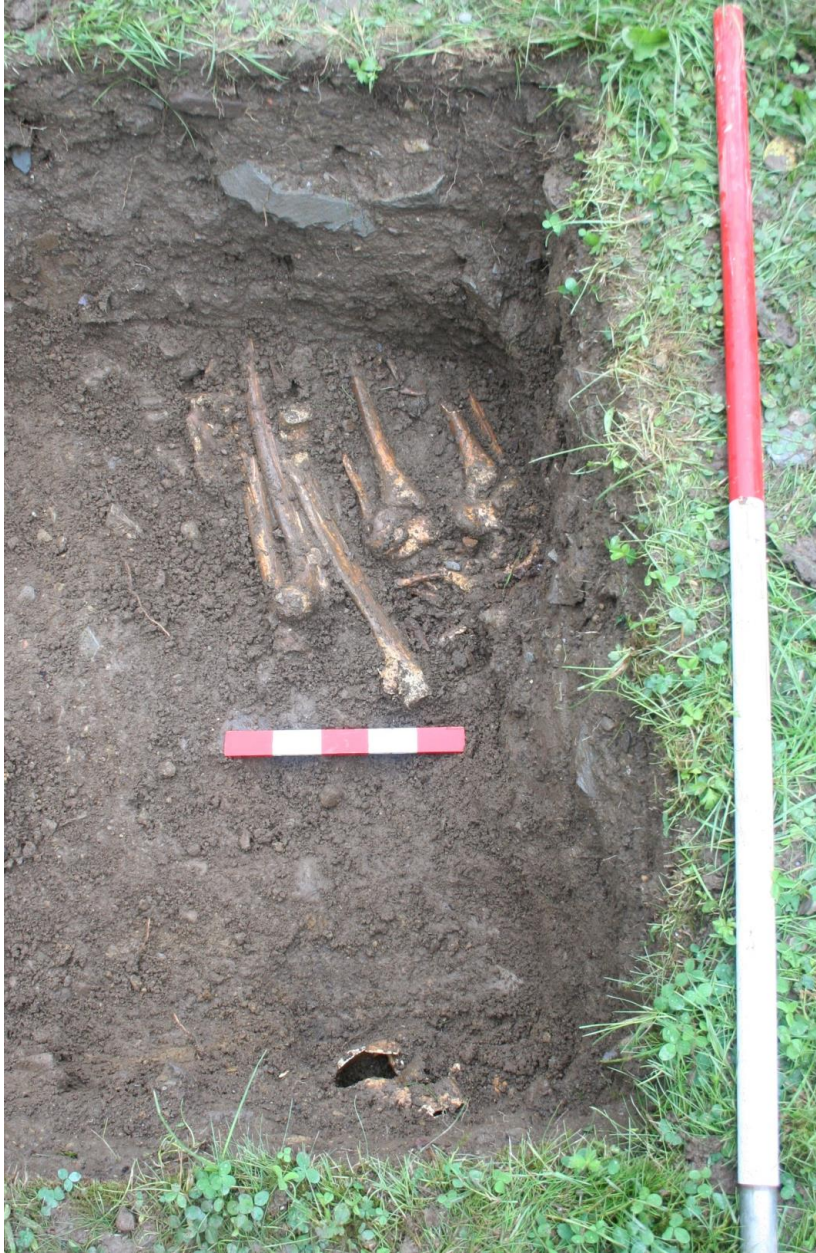
Plate 22: Trench 4, skeletal remains C413 & 414, skull C409 visible at the bottom, looking ENE

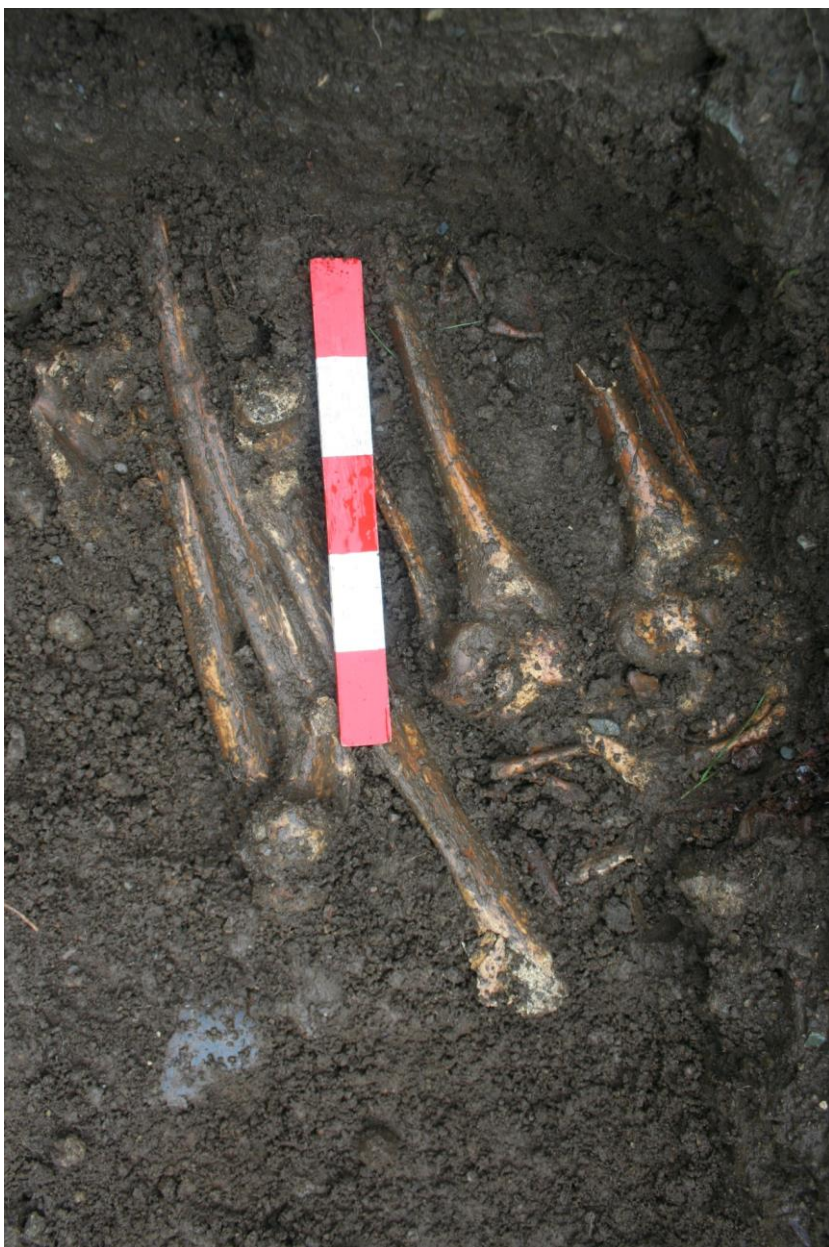
Plate 23: Trench 4, close up of articulated skeletal remains within coffin, C413 (The feet and lower long-bones can be seen). Also disarticulated long-bones C414 laid alongside articulated remains, note the position of the femur, lying in an opposing direction to the articulated remains, photograph taken looking WSW.

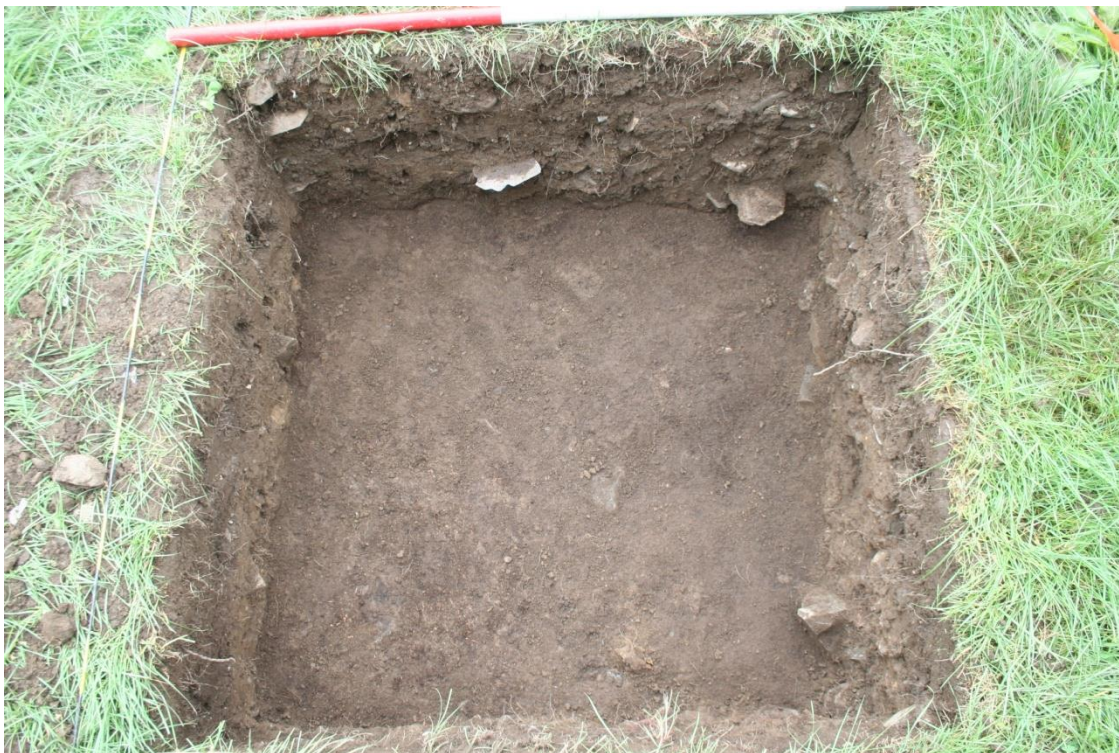
Plate 25: Trench 5, C505 post removal C504, remains of a disarticulated and fragmented vertebra from C504 impressed into C505 surface at bottom centre, looking SSE

Trench 5, which was also fully hand-excavated, was situated along the eastern limit of the development area, directly to the northeast of the grave slabs and measured 1m x 1m. Removal of sod (C501) and topsoil (C502) revealed layers of disturbed graveyard soil (504), and loam (C503), with brick, glass, ceramics, mortar, plastic, cut stone, fragments of graveyard furniture, a single coffin nail, and a few fragments of disarticulated human bone. Removal of these layers exposed a fairly level deposit of dark blackish-brown humic material (C505) at 0.37-0.43m, of very similar consistency to garden compost, with fragments of disarticulated human remains from the layer above partly impressed into the surface. One long fragment of iron, possibly grave furniture, was uncovered from C505, and removal of this layer exposed a thick deposit of angular stones (C506), which in turn were removed directly onto the surface of the shattered natural bedrock, encountered at a depth of 0.65-0.70m. No further finds or features were noted in this basal deposit. It was anticipated, given the

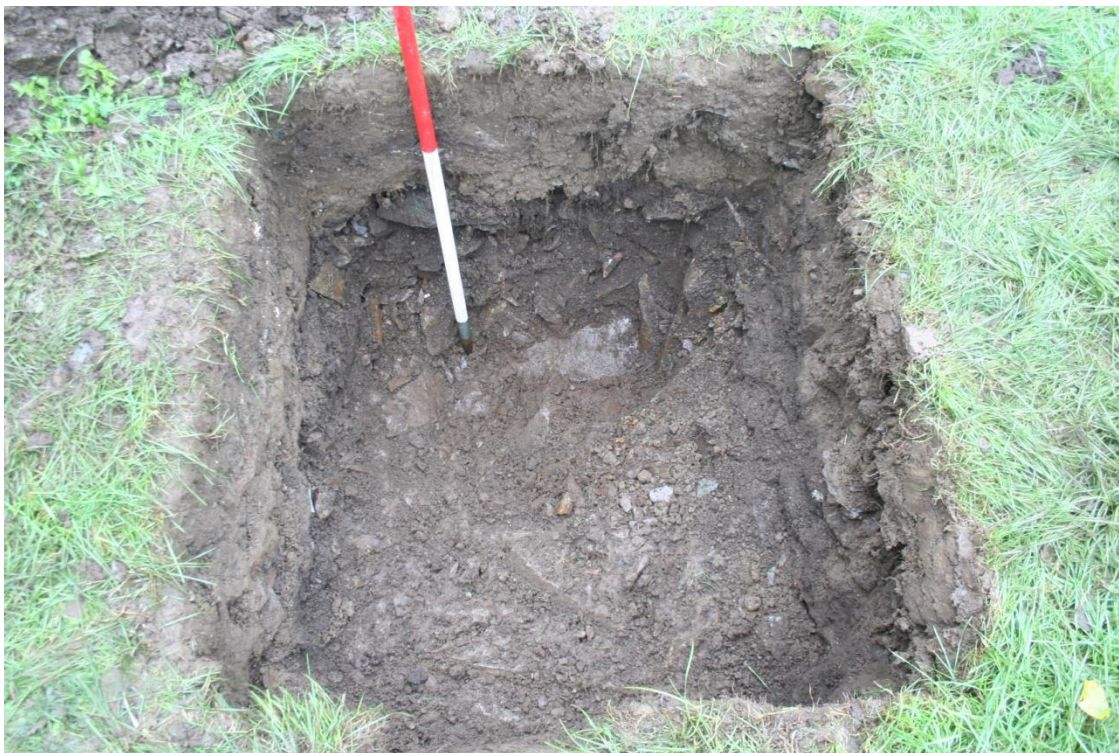
Plate 27: Trench 5, post-excavation showing shattered bedrock surface, looking ENE

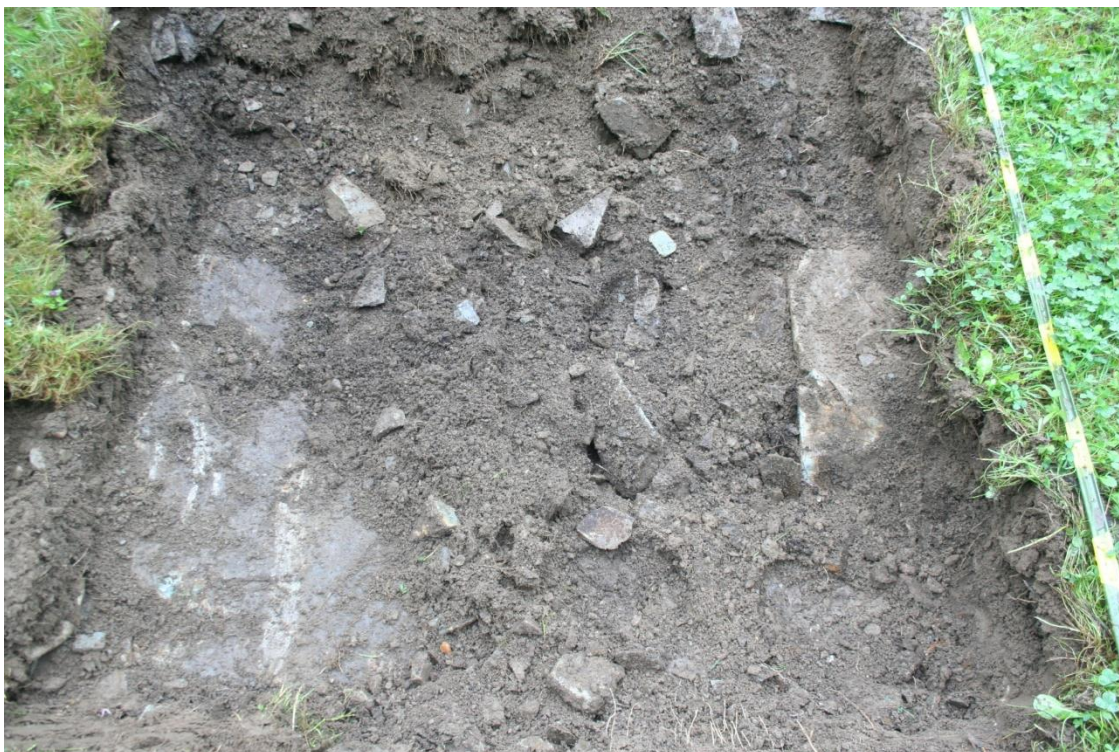
Plate 28: Trench 6, mechanically excavated, showing solid bedrock immediately below the surface, looking SSE

This was a mechanically excavated 1m x 1m trench situated along the southwestern limit of the development area and roughly mid-way between Trenches 2 and 3. Its excavation revealed sod (C601), topsoil (C602) and stony, sandy clay (C603) coming directly down on to the surface of the shattered natural bedrock of the site at a depth of approximately 0.2m. No finds or features of archaeological interest were uncovered.
