EVALUATION REPORT No. 273

Freeduff Presbyterian Church,
3 Oldtown road, Freeduff,
Cullyhanna, County Armagh

Licence No.: AE/13/133E

Report Date: 20/09/2013

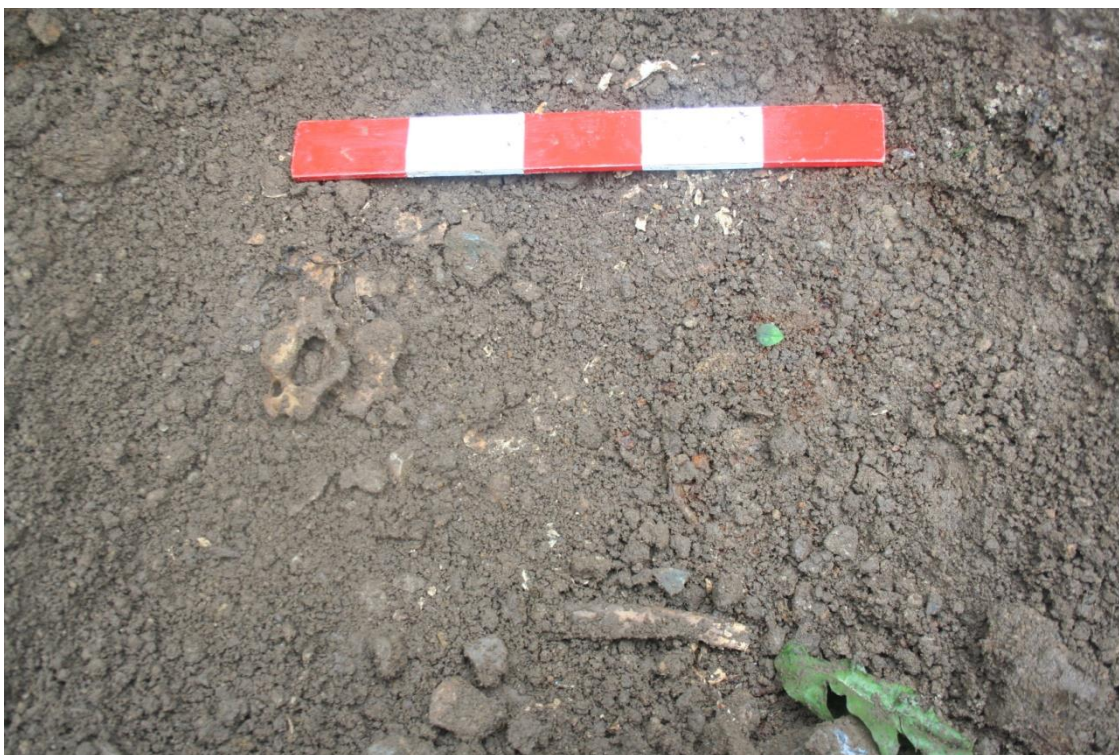
Plate 29: Trench 7: Articulated human remains within a coffin (C705), fragments of the coffin lid/plate may still be surviving although the skeletal remains themselves are, like C410 in trench 4, rather delicate and easily fragmented. Looking NNW.

This was a 1m x 1m, initially mechanically excavated trench positioned at the northeastern edge of the development area, between the recumbent grave slabs and the concrete edging which surrounds the currently upstanding church. This was the final trench and was located in order to further determine whether sinking of the foundations would disturb human burials along this northeastern edge. The trench was at first, mechanically excavated as it was not anticipated that burials would be encountered. No remains had been found in either of the two trenches previously excavated along this edge of the development area and the grave plan provided (figure 4) does not show any marked graves in this location. Sod (C701), loamy topsoil (C702) and mottled brown silty clay (C703) were removed, similar to layers encountered in Trench 4. From this point onwards, excavation of the trench continued by hand as a layer of mottled grave soil (C704) was encountered. Investigation of this layer revealed the intact, articulated, upper skeletal remains of an individual, within the outline of a coffin (C705). No evidence of a grave cut was observed-its limits likely lie beyond the trench boundaries. This burial was briefly cleaned back and photographically recorded before being covered with tarpaulin and the trench back-filled. As with the skeletal remains found in Trench 4, the burial was found to be aligned northeast-southwest, with the head at the southwestern end.

Where skeletal remains were uncovered, tarpaulin was laid down to protect remains from back-fill. All trenches were back-filled and the sod where possible, was re-instated.
