Monitoring Report No. 270

**6 Saul Street
Downpatrick
Co. Down**

AE/13/142

R/2007/0947/F

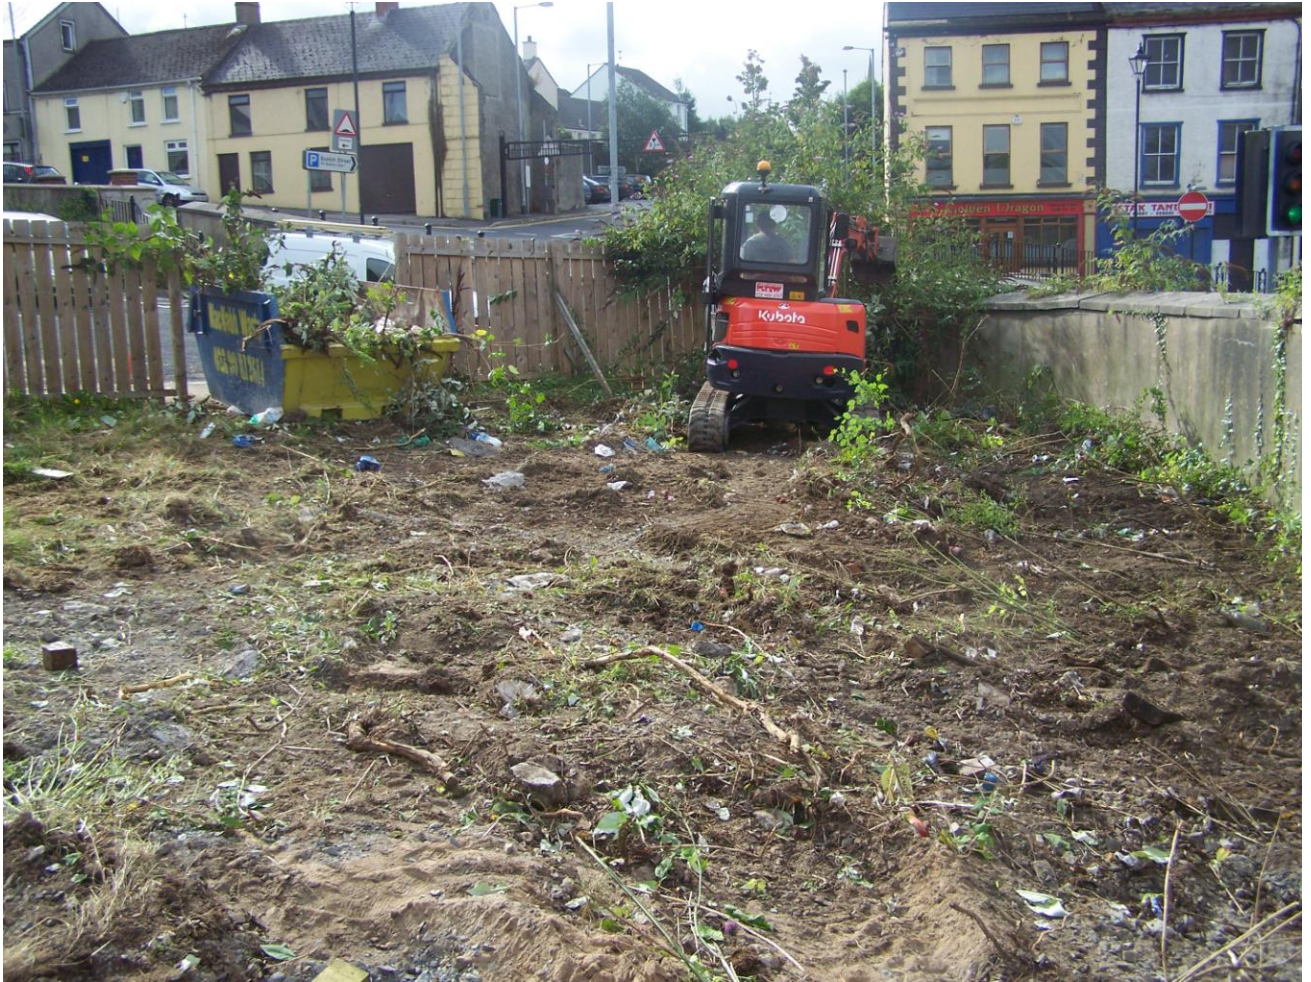
Plate 1: Development site R/2007/0947/F during the clearance of rubbish and shrubbery, looking south.

An archaeological investigation was carried out at the site of a proposed development for the Simon Community NI (Planning Ref: R/2007/0947/F) on behalf of the Northern Ireland Environment Agency (NIEA). The site is located at 6 Saul Street, Downpatrick, Co. Down (Figure One), on the west facing slope of a small drumlin. The site exists as a roughly triangular piece of waste ground (Figure Two) approximately 20m (north/south) by 14m (maximum length east/west). It is bounded on the west and south by a retaining wall and on the north and east by a wooden fence. The archaeological investigation was prompted by the location of the proposed development, being in proximity to the historic centre of Downpatrick (DOW 037:091) as well as the likely location of an Augustinian Priory (St. Thomas the Martyr DOW 037:101). Prior to the investigation the site existed as waste ground, with thick shrubbery present particularly in the southern area. The site had been used in the recent past for dumping, with a lot of rubbish being cleared along with the shrubbery to allow the investigation to proceed (Plate 1).

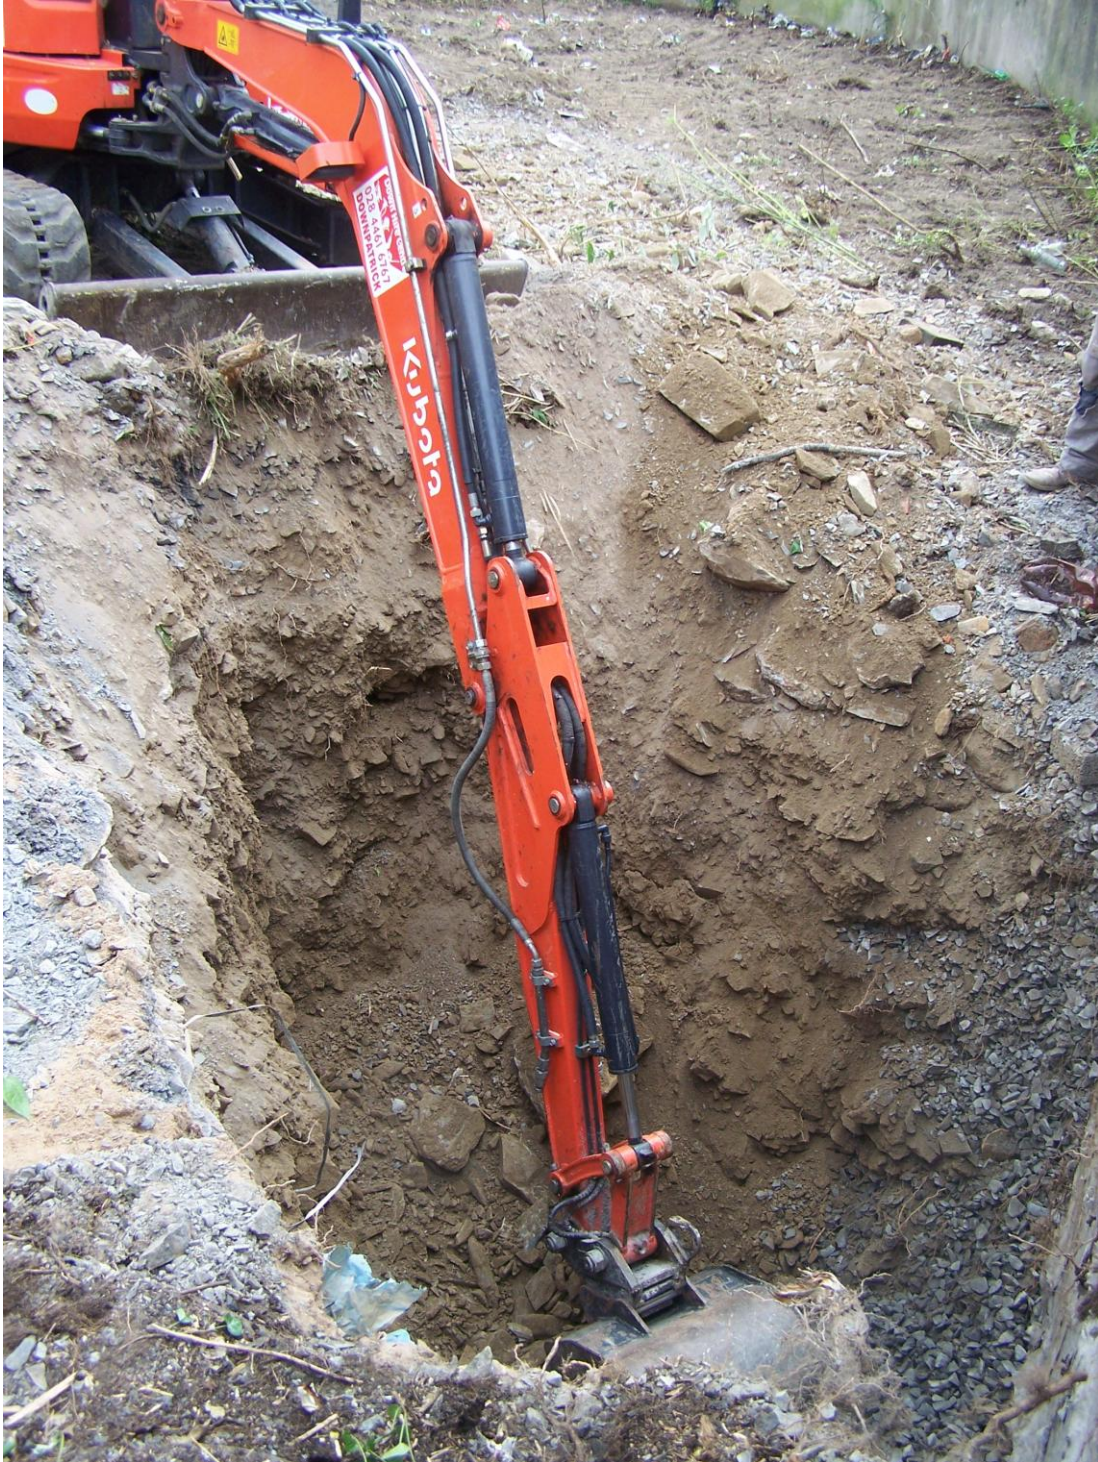
Plate 2: Mid excavation shot of Context No. 104 showing the depth and unstable nature of the deposit, looking south.

The uppermost deposit consisted of a series of discreet lenses of hardcore gravel and a light to mid brown sandy loam (Context No. 104) with frequent inclusions of medium to large angular stones throughout (average size 0.2m x 0.4m x 0.4m). Due to the obviously modern nature of the deposit (Context No. 104) it was excavated as a single stratigraphic unit. Numerous machine made bricks were noted throughout the deposit (Context No. 104) as well as plastic pipe fragments and plastic sheeting. The deposit extended across the entirety of the development site and varied in thickness from 0.8m in the south to over 2.7m in the north part of the site. Excavation in this area did not reveal the base of this deposit due to health and safety concerns about depth and stability (Plate 2).

Excavation ceased at this depth due to health and safety concerns of the depth and stability of the overlying deposit (Context No. 104).
