ULSTER ARCHAEOLOGICAL SOCIETY

Survey Report: No. 18

**Survey of Lime Kiln at Murlough Bay
County Antrim
UAS/09/03**

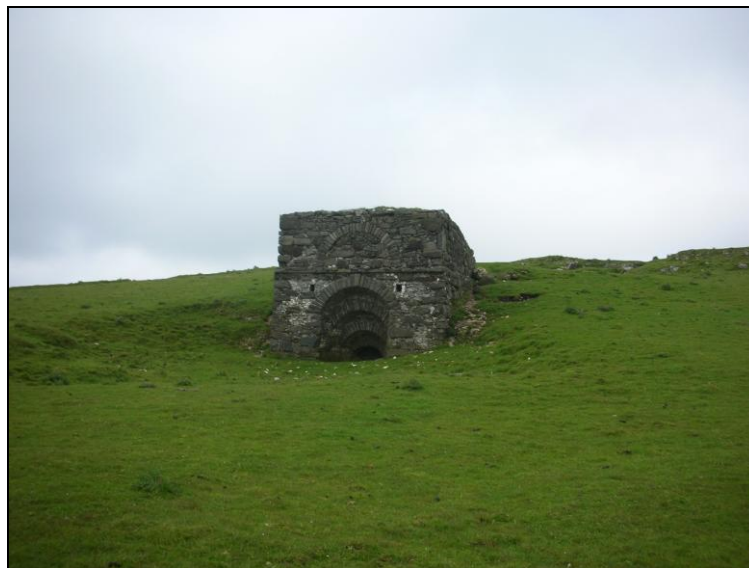
Figure 6: Lime Kiln in the townland of Bighouse

In the vicinity of the Lime Kiln at Murlough Bay, there are two other lime kilns. One is 1km to the west-south-west and is found in the adjacent townland of Bighouse. The other is 0.6km to the east-north-east and is in the townland of Knockbrack.

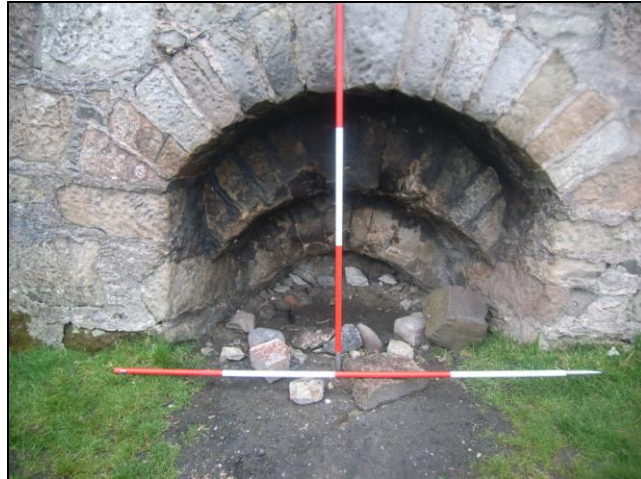
3. Draw-hole or stoke-hole: This was located at the front, providing draught and access to the fire and was also where the lime was withdrawn from the kiln. It was usually designed to accommodate one or two men and sometimes a cart. Some, like the one at Murlough Bay, had an arch built in stone or brick and was flared inwards.

Figure 12: Draw-hole at the Lime Kiln, Murlough Bay

At the draw-hole there is a triple arch and directly above the archway, there are two quite large vents cut into the outer casing. The larger vent measures approximately 30cm by 17cm and the second vent measures 20cm by 17cm approximately.

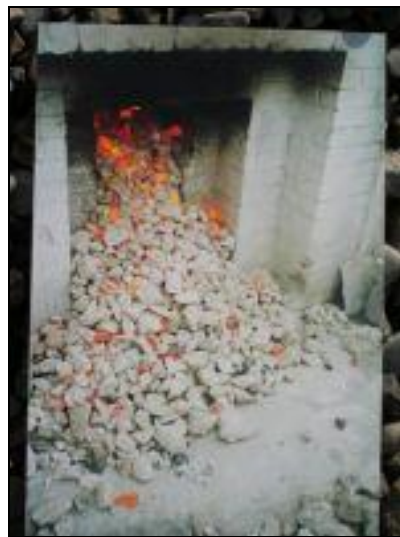
Figure 13: Example of burnt lime, www.buildinglimesforumireland.com

Alternating layers of limestone and fuel were stacked on top of the grate, which was fixed over the fire-box. As the fuel burned to decompose the limestone, lime dropped through the draw-hole. Additional layers of both limestone and fuel were added at the top and this process continued for weeks or even months. The draw kiln produced large amounts of lime and proved to be fuel-efficient too. However, the quality of the lime produced depended upon the knowledge and skill of the lime-burner, in maintaining the necessary temperature in the kiln and also in determining the speed and duration of the burning process.

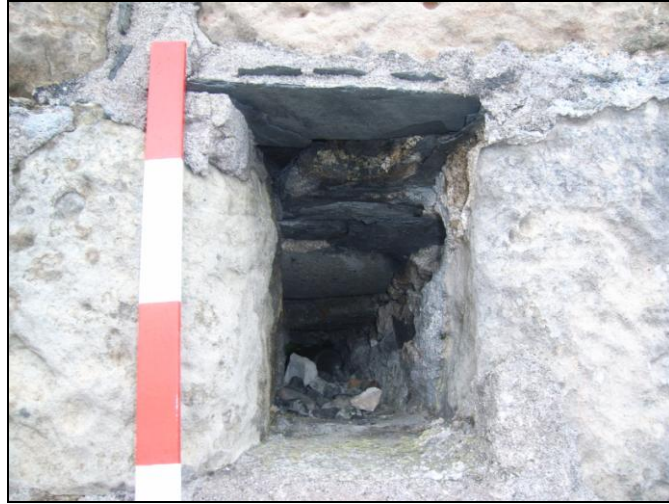
Figure 15: Larger vent at the Lime Kiln, Murlough Bay

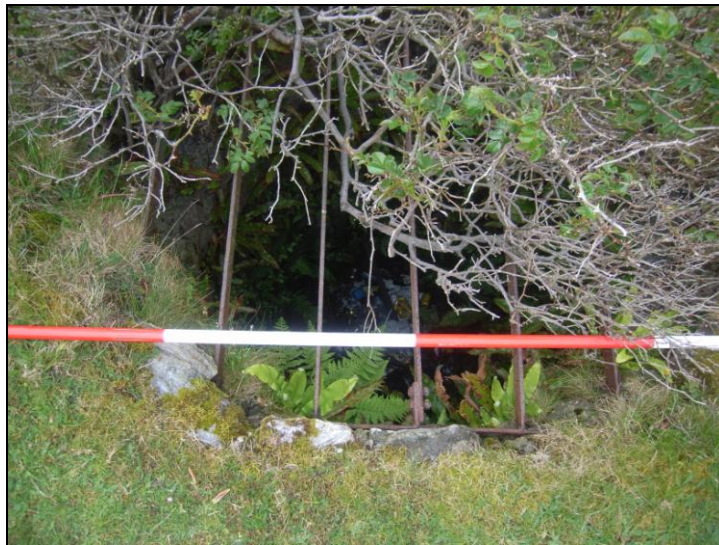
The top of the flue is sealed with a removable iron grille. The top of the lime kiln is reached by a steep path from the roadway from the North and also by a winding path to the West, towards the ruins of a cottage behind the lime kiln. This cottage may well have once been occupied by the lime-burner and his family. This path is revetted on the eastern side.

Figure 16: Iron grille at the top of the Lime Kiln flue, Murlough Bay

At present the lime kiln is quite a robust structure and seems to be in good repair. Vegetation may appear to protect some parts of the lime kiln, but could cause problems in the future, if left to grow out of control. The flue contains a variety of litter, which may indicate a risk of vandalism to the monument. Although attractive ruins of lime kilns, like the one at Murlough Bay, still exist throughout the countryside, it is a sad reality that the overwhelming majority of those recorded in the 1840s have been destroyed. It should be our aim to prevent the further destruction of lime kilns, but at the moment sites dated after AD 1700 are not normally included in the SMR and as a result, do not receive the necessary legal protection. This must be a cause for concern. This Lime Kiln should be considered for some form of statutory protection.

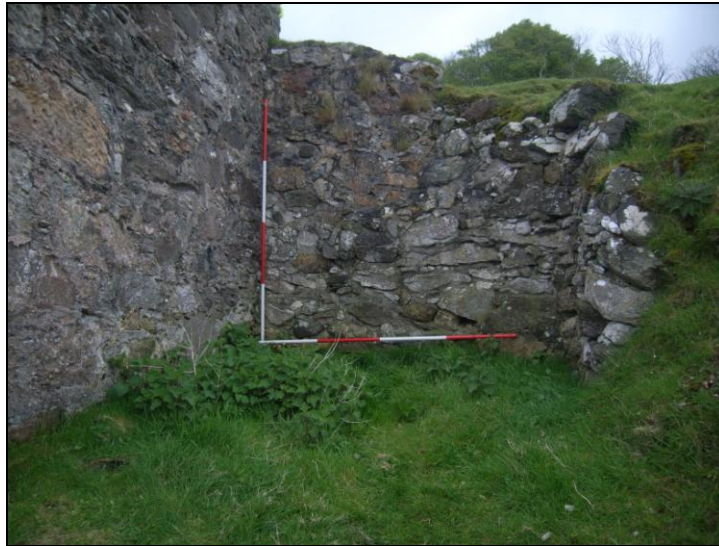
One unusual feature of this particular lime kiln is the stone lean-to built at one side. This may have been used to store fuel or indeed the limestone itself and may also have offered shelter from the elements, when needed.

Figure 17: Stone lean-to at the Lime Kiln, Murlough Bay

A small-scale excavation could help determine the actual purpose of the lean-to and provide valuable information about the lime kiln itself.
