Data Structure Report No. 103

Excavations at Arney, Co. Fermanagh

Brian Sloan and Dermot Redmond

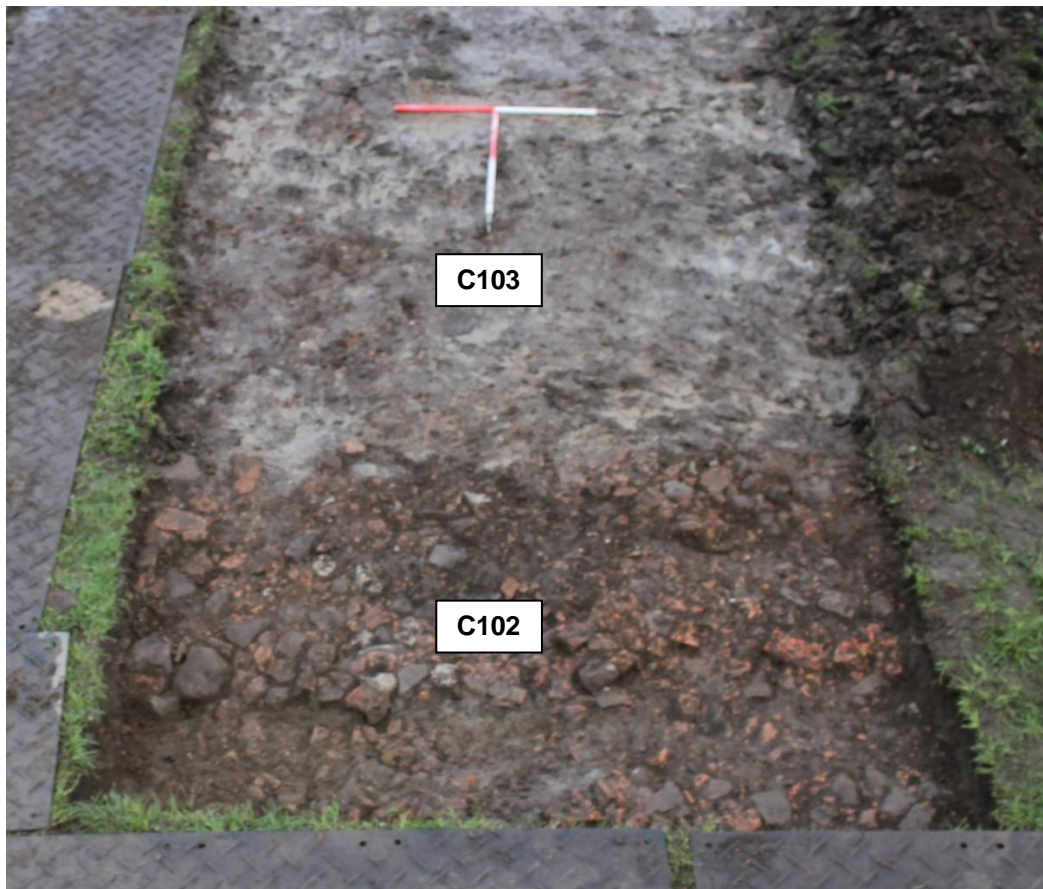
Plate 1: View of probable demolition deposit (Context No. 102), looking east.

- 3.3.3 In the west of the trench the sandy clay sod and topsoil layer (Context No. 101) was removed to reveal a deposit of brick fragments within a matrix of a firm brown sandy clay (Context No. 102). This deposit was localised to the western end of the trench and measured 1.9m (east/west) by 3m (north/south). The deposit varied in thickness between 0.03m – 0.19m, with a noticeable slope towards the western end of the trench. Artefacts recovered from this deposit (Context No. 102) include those that would be expected to be associated with a schoolhouse (e.g. fragments of ruled slate, styli and fragments of ink wells) as well as a coin (although very abraded, making the date illegible). It is thought that the brick-fragment rich sandy clay (Context No. 102) originates from a demolition layer (Context No. 111) which has become disturbed by the construction of a field drain (Context No. 114), with Context No. 102

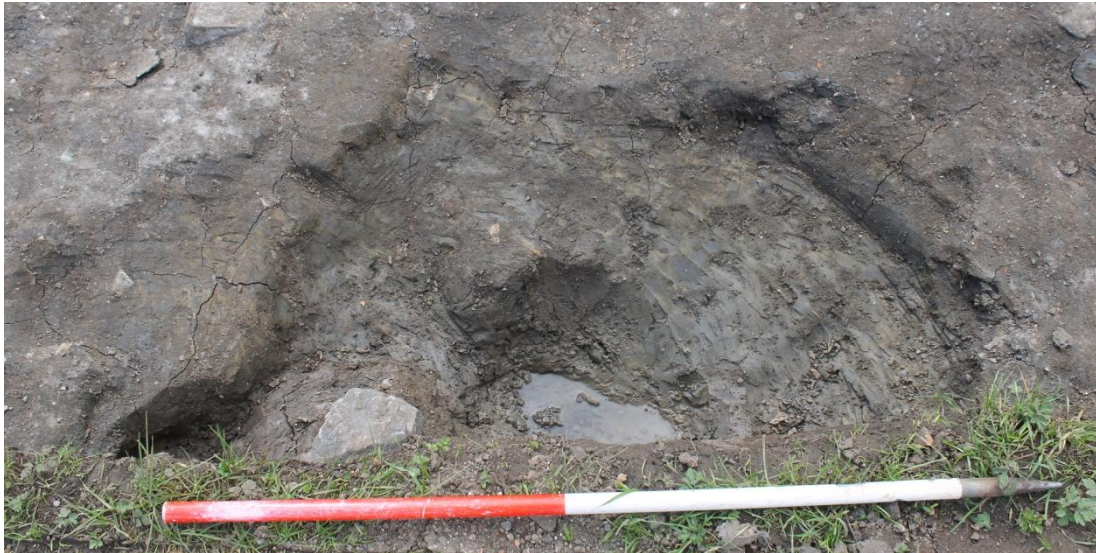
Plate 3: Post-excavation view of shallow pit (Context No.116), looking south.

- 3.3.6 The tenacious yellow clay (Context No. 122) measured 1.09m (east/west) by 0.46m (north/south) and had a maximum thickness of 0.13m. The deposit (Context No. 122) was relatively sterile save from the very occasional small rounded stones (average size 30mm x 20mm). The cut of the pit (Context No. 116) was sub circular in plan with gently sloping sides to an irregular, slightly concave base. Although the feature carries on into the section, the dimensions of the pit were 1.91m (east/west) by 0.69m (north/south) with a maximum depth of 0.46m. No artefacts were recovered from either fill (Context Nos. 117 and 122) of the pit (Context No. 116).

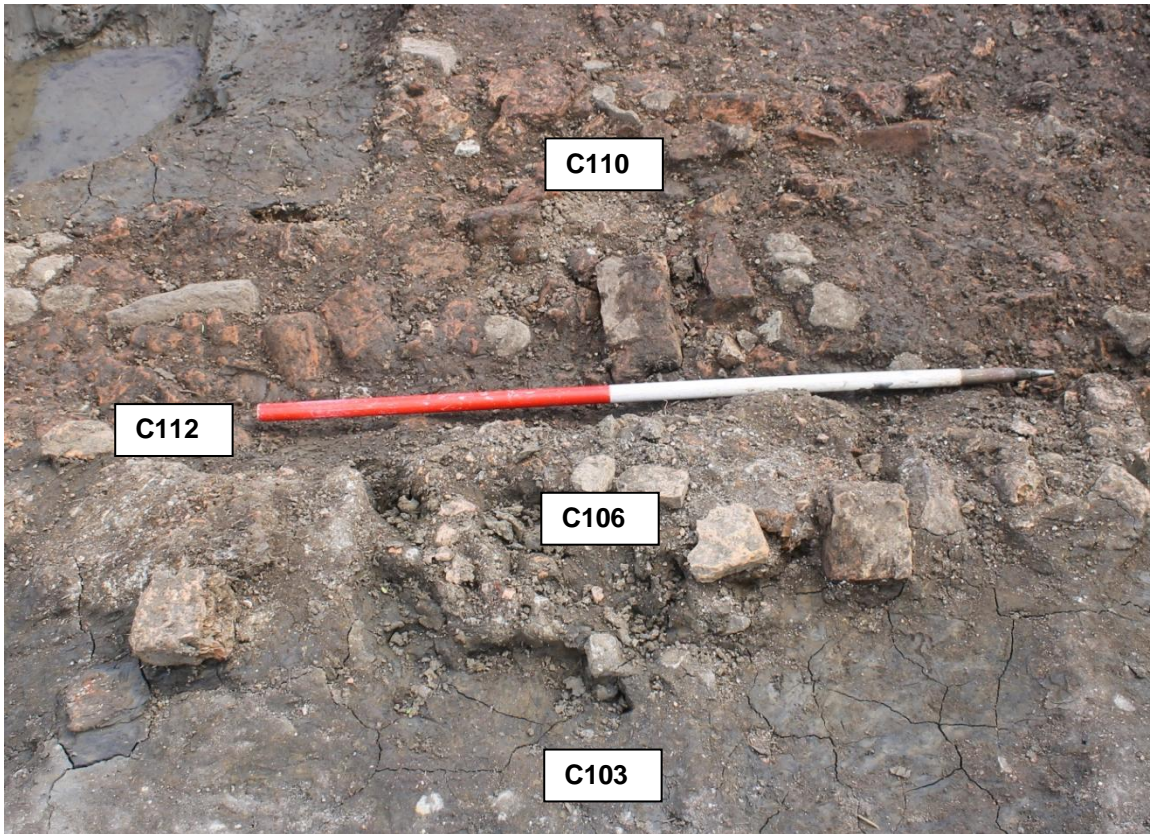
Plate 6: Remnants of the rear wall of the schoolhouse (Context No. 106), looking east.

3.3.15 In the eastern end of the trench, the removal of the demolition deposit (Context No. 110) revealed features associated with the rear of the schoolhouse including the truncated remains of a wall (Context No. 106), a drain (Context Nos. 112/126) as well as a possible rubbish pit (Context Nos. 118/123/124). The rear wall of the schoolhouse (Context No. 106) consisted of a roughly north/south aligned linear of mortar and fragmentary bricks (Plate 6). This spanned the width of the trench (3m north/south) and was on average 0.38m wide (east/west). This deposit (Context No. 106) was a maximum of 0.16m thick and directly overlay the subsoil (Context No. 113). Adjacent to the wall (Context No. 106), and running directly parallel to it, was a shallow negative feature (Context No. 112) which is interpreted as a small drain that may have directed runoff rainwater from the roof of the schoolhouse. The cut of the drain (Context No. 112) had shallow sloping sides and a concave base and measured 3m (north/south) by 0.4m (east/west) and approximately 0.3m deep. The fill of the drain (Context No. 126) consisted of a friable mid to dark brown sandy clay with frequent inclusions of fragmented brick and small rounded stones. It is possible that the fill of the drain (Context No. 126) originated from the overlying demolition deposit (Context No. 110).

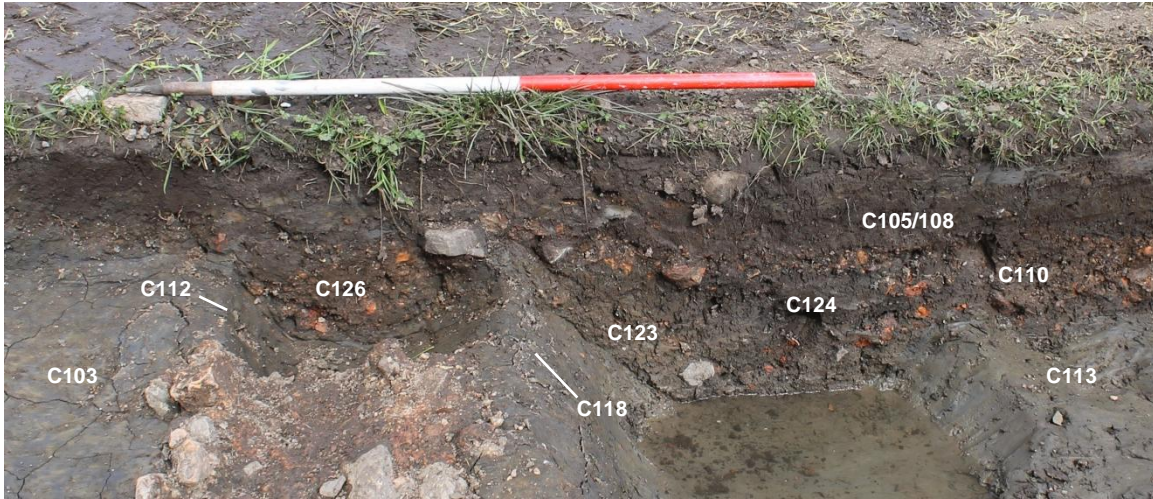
Plate 7: Eastern portion of the south-facing section, showing the drain (Context No. 112) and fill (Context No. 126), as well as the possible rubbish pit (Context No. 118) and associated fills (Context Nos. 123 and 124).

3.3.16 To the immediate east of the drain (Context No. 112) a shallow pit was encountered (Context No. 118). This feature was sub-rectangular in plan with relatively gently sloping sides and concave base. The cut of the pit (Context No.118) measured 0.82m (east/west) by a maximum of 0.6m (north/south), although this is not the full dimensions of the feature as it continues into the south-facing section of the trench. The pit (Context No. 118) was a maximum of 0.47m deep and was filled by two deposits (Context Nos. 123 and 124). The stratigraphically earliest of these fills was a deposit of tenacious mid brown clay (Context No. 123) with frequent inclusion of small angular stones (average size 40mm x 60mm) as well as the occasional fleck of charcoal. This deposit was only encountered along the western edge of the feature and was on average 0.18m thick. The mid brown clay (Context No. 123) was overlain by a dark greyish brown silty loam (Context No. 124) that comprised the upper fill of the feature (Context No. 118). The silty loam deposit (Context No. 124) was friable in nature with inclusions of flecks of charcoal and small rounded stones frequent throughout. The excavation of this deposit (Context No. 124) produced numerous sherds of pottery and animal bone (as well as a possible fragment of eggshell) and was a maximum of 0.47m thick. This feature is interpreted as representing a rubbish pit associated with the use of the schoolhouse.

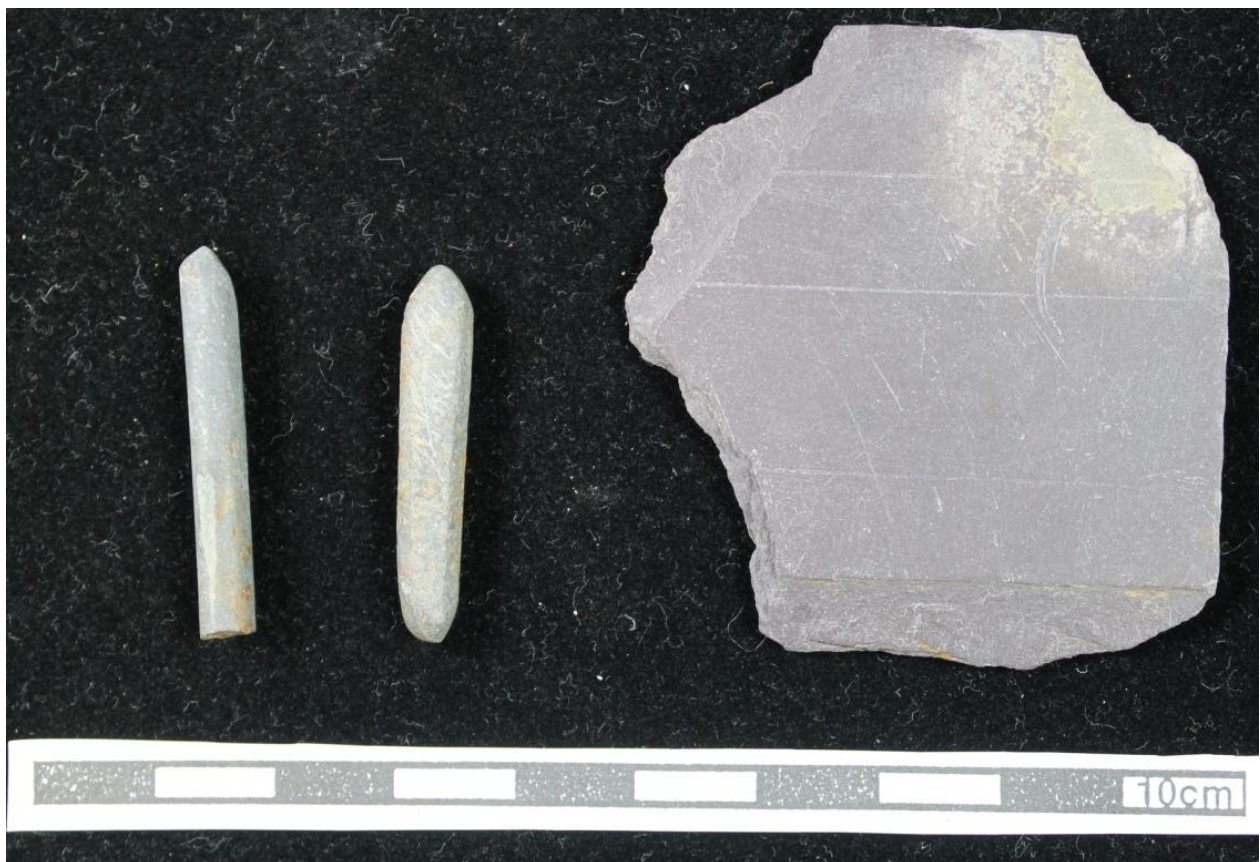
Plate 9: Incised writing slate and styli recovered from Trench One Context No. 103 (scale 10cm).

3.3.25 A number of artefacts were recovered during the excavation of Trench One can be directly aligned to its use as a schoolhouse. The majority of these finds were recovered pressed into the surface of the clay floor (Context No. 103) as well as from deposits associated with the demolition of the structure (Context Nos. 102, 104 and 110). The artefact assemblage includes sherds of nineteenth century ceramics (including several pieces of locally produced '*Florencecourt Ware*' of probable mid to late nineteenth century date), fragments of glass and corroded iron objects. Several artefacts associated with the use of the structure as a schoolhouse were recovered including fragments of writing slates and styli (Plate 13) as well as a fragment of an inkpot.

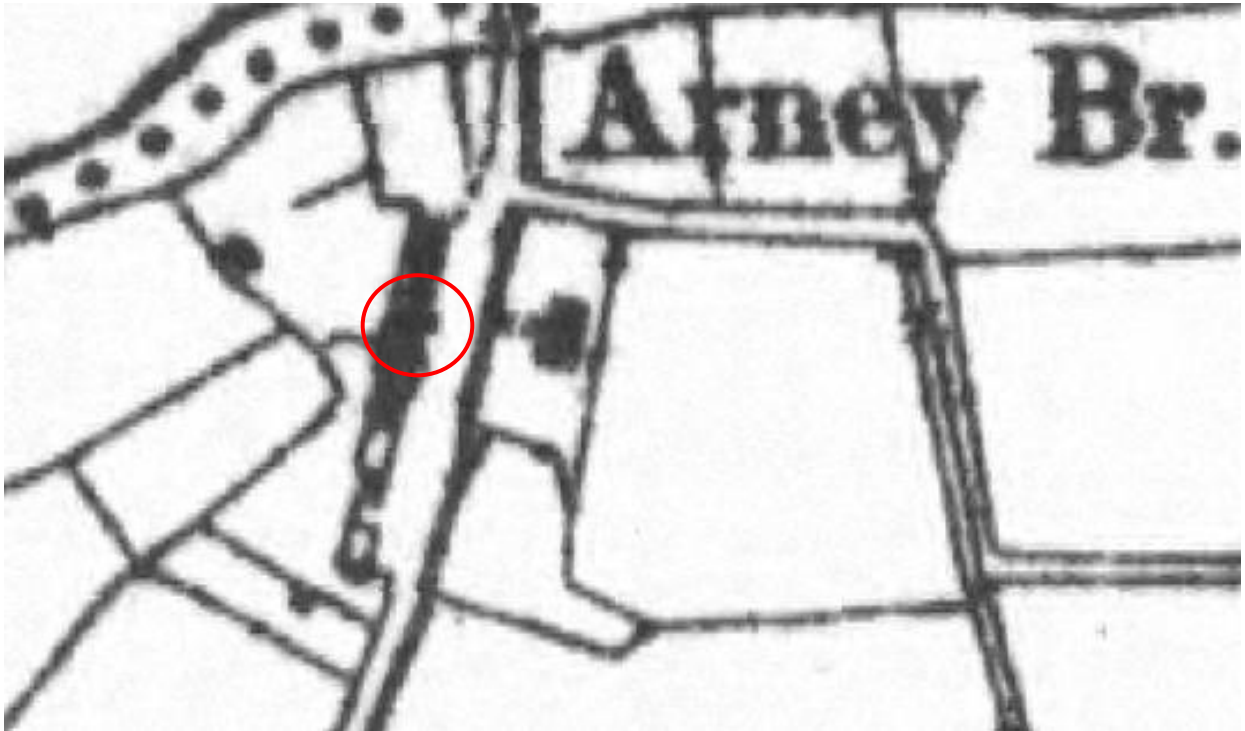
Figure 12: The approximate location of Trench Two as depicted on the c.1907 OS map. It is possible that the structure shaded white is the byre of the house, suggesting that the modifications to the structure had occurred prior to c.1907.

3.5.1 Trench Two focused on the upstanding albeit ruinous cottage at the end of the row of buildings along the western edge of the road locally known as Robert Lamb's house. A mechanical excavator equipped with a smooth edged "sheugh" bucket was used to clear the majority of the debris from the interior of the structure, with the final 0.1 – 0.3m manually excavated. The excavation revealed that the structure had a cement floor, intact fireplace and revealed information regarding the development and layout of the structure. Artefacts

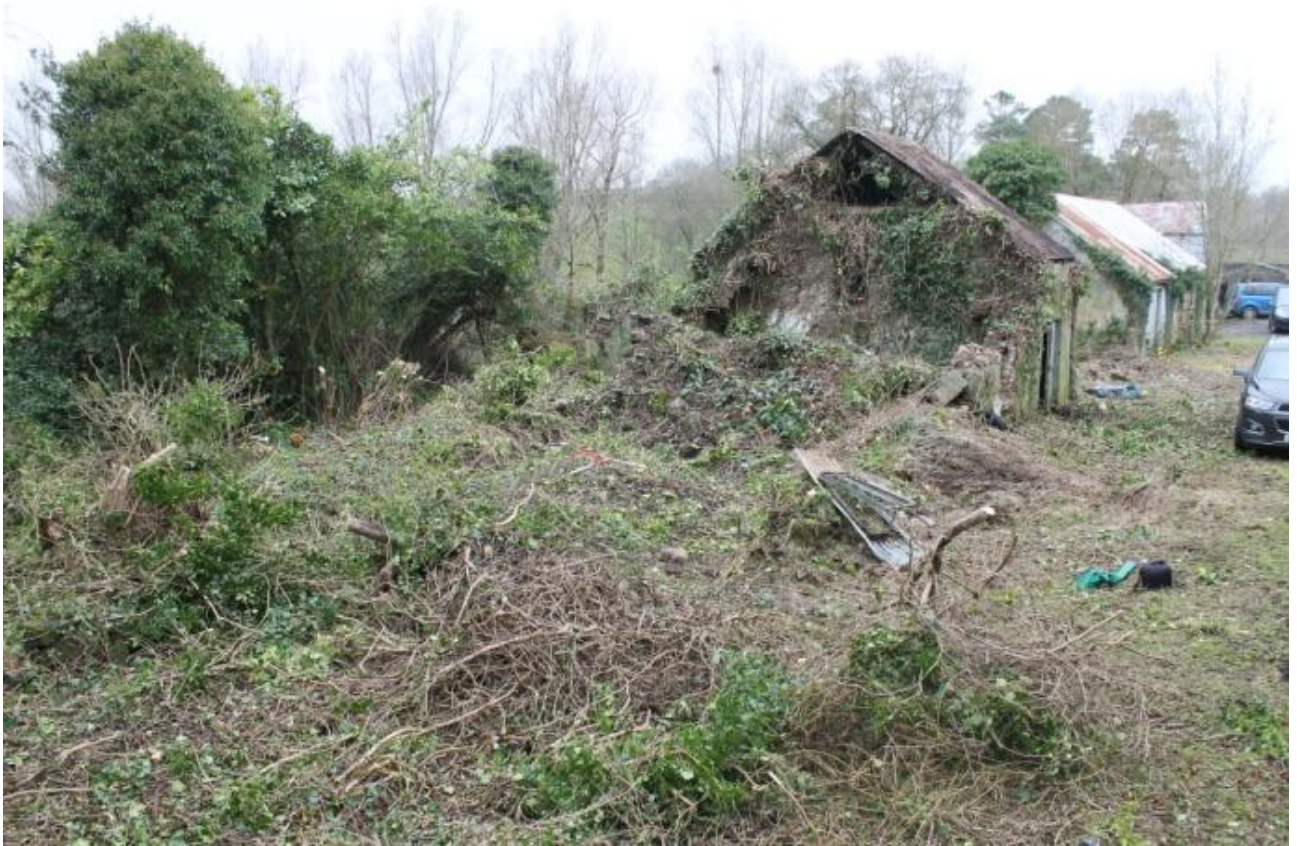
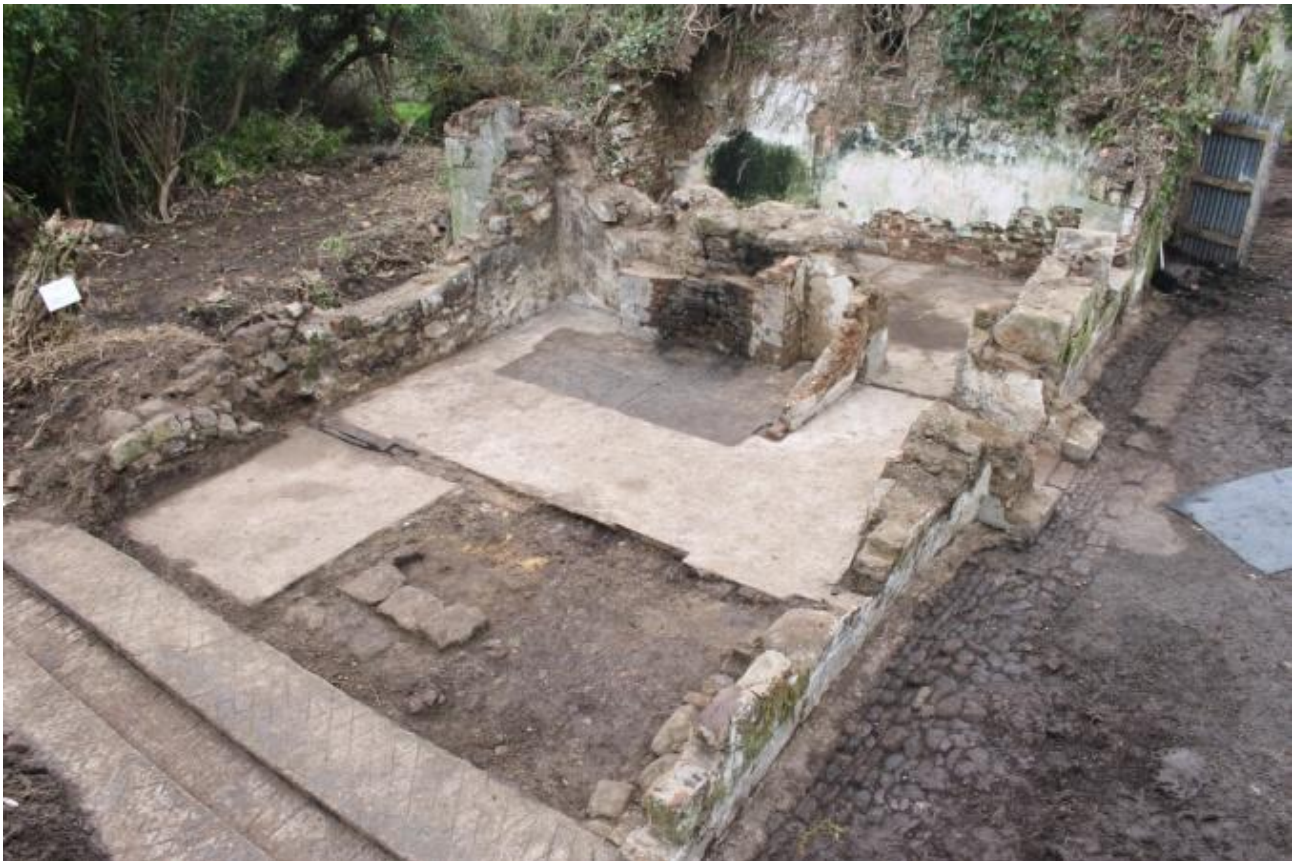
Plate 10: Overview of Trench 2, showing a pre-excitation view (top) and a post-excitation view (bottom).

3.5.2 The stratigraphically latest deposit encountered during the excavation of this area was a mixed deposit of organic matter and rubble (Context No. 201). Despite the make-up of this deposit being comprised of several distinct layers and deposits, it was mechanically removed as one stratigraphic unit. The rubble and organic deposit (Context No. 201) varied in thickness from a maximum of 1.5m in the northern part of the building to a minimum of 0.4m in the south.

- 3.5.3 The rubble and organic deposit (Context No. 201) was removed to reveal several contexts associated with the construction and use of the structure. These include the remains of walls (Context Nos. 202, 203, 208, 209, 210, 211, 217), fireplaces (Context Nos. 206 and 207) and cement floors (Context Nos. 212, 213, 214 and 215) (Figure 9). It also revealed several contexts relating to the redevelopment and modification of the building, the most telling of which are a blocked up doorway which had been turned into a window following the expansion of the structure to the north-east (Context Nos. 204/205).

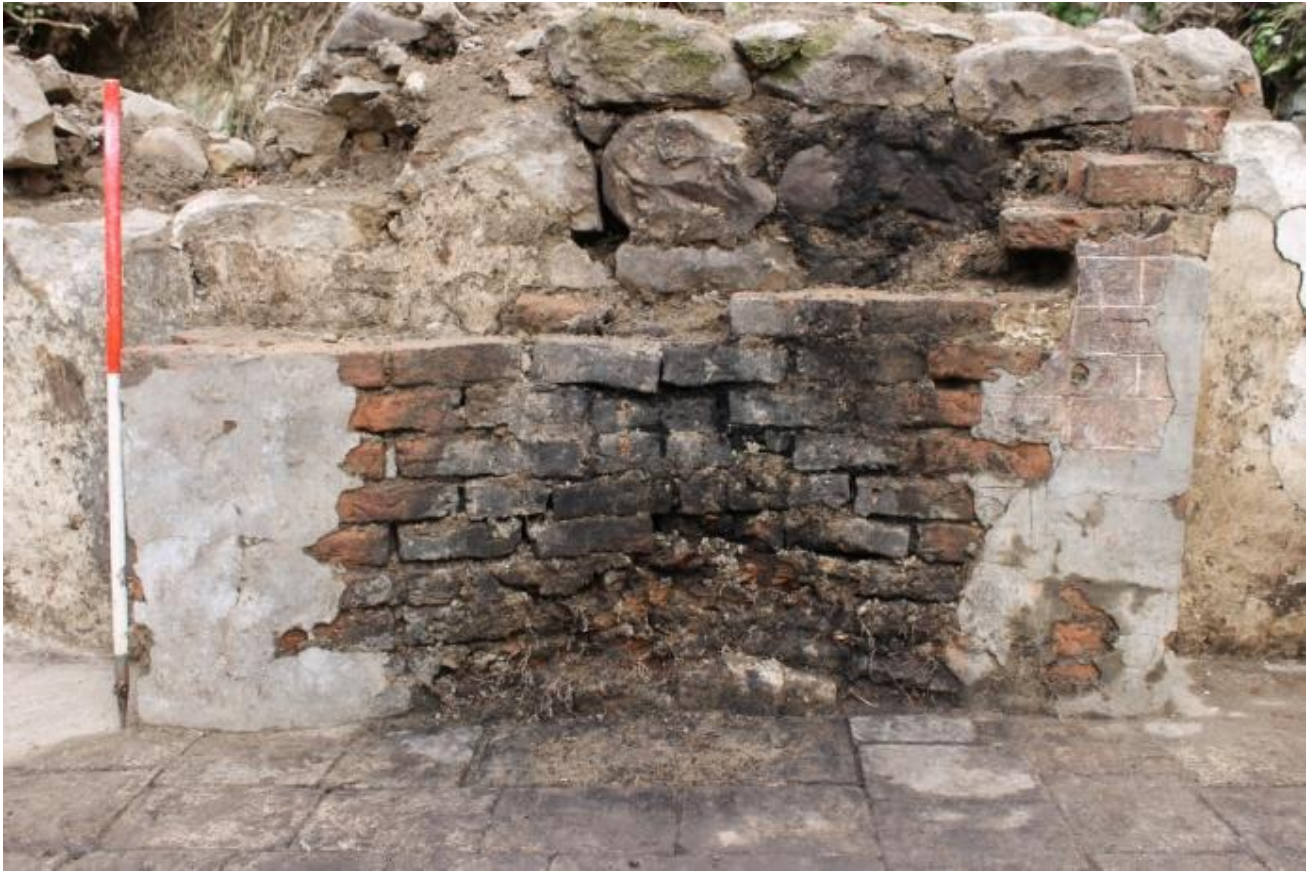
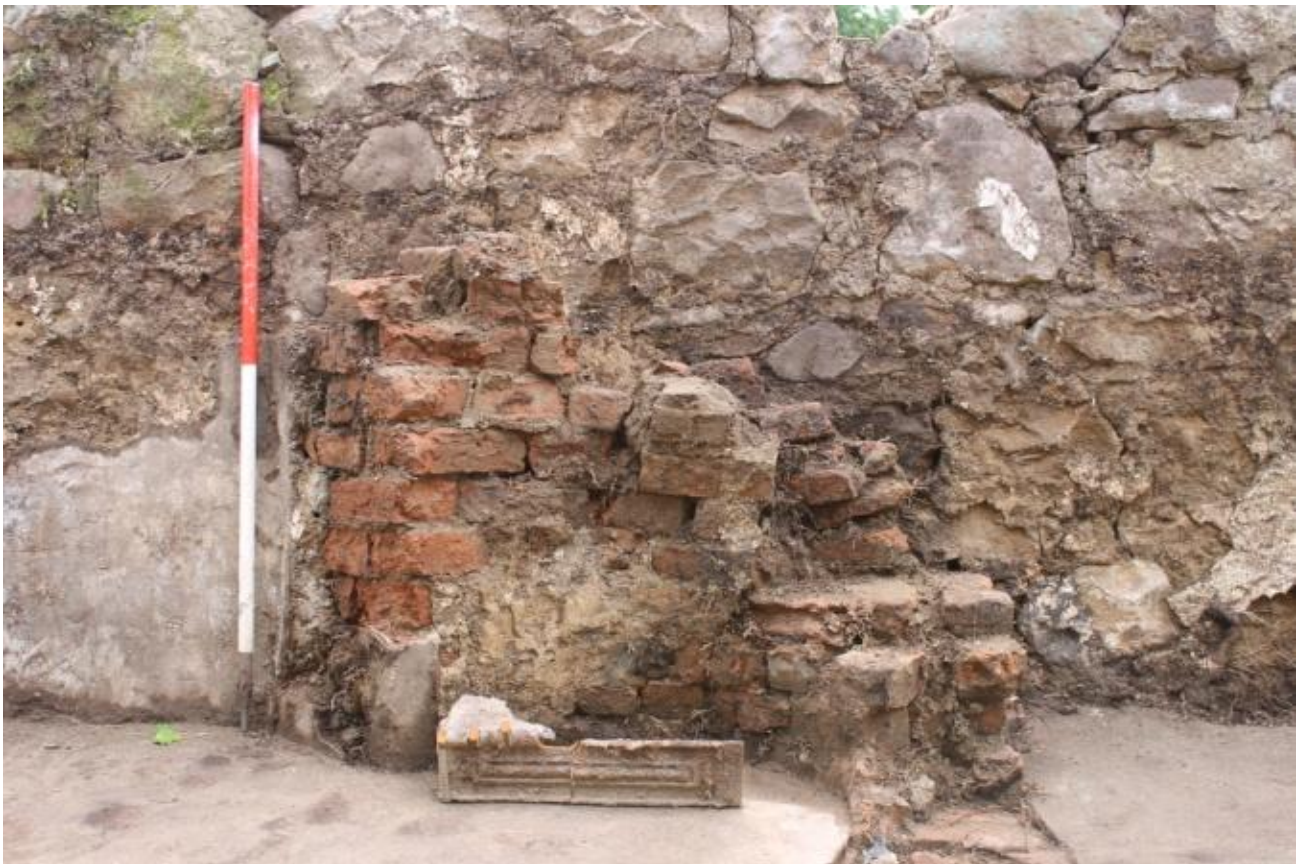
Plate 11: Main fireplace (Context No. 207) (top) and fireplace in the parlour (Context No. 206) (bottom).

- 3.5.4 The middle room was the original extent of the house, with the cottages on either side being purchased to extend the living space in both directions, for a parlour and bedroom to the north-east and two bedrooms to the south-west (Myles Keogh *pers comm.*). It is not possible to tell when exactly this period of renovation and modification took place, but it appears that very little other than the exterior wall of the cottages (Context No. 217) remains original. The exterior walls of the structure (Context No. 217) were on average 0.5m thick and consisted of large rounded boulders bonded with a crumbly, beige coloured lime mortar. Through the duration of the excavation, this mortar became increasingly weathered, having previously been protected from the overlying modern detritus (Context No. 201). The original flooring was replaced with cement (Context Nos. 212, 213, 214 and 215), evidenced by the fact that it respects the new internal divisions that were constructed (Context Nos. 208, 209, 210 and 211) being single brick walls instead of the 0.5m thick stone walls. The two fireplaces (Context Nos. 206 and 207) appear to also have been constructed at this time as they appear to sit directly upon the cement floors of the structure. The smaller of the two (Context No. 206) was built in the northern extension, in what Myles Keogh described as the parlour of the house, which was a locked room and kept for guests. The larger (Context No. 207) was in the middle room of the house. A semi-circle of burning damage to the paving stone is evident in front of this fire that is absent in the parlour, indicating that this fire was lit with much higher regularity, suggesting that this is the main living area of the house.

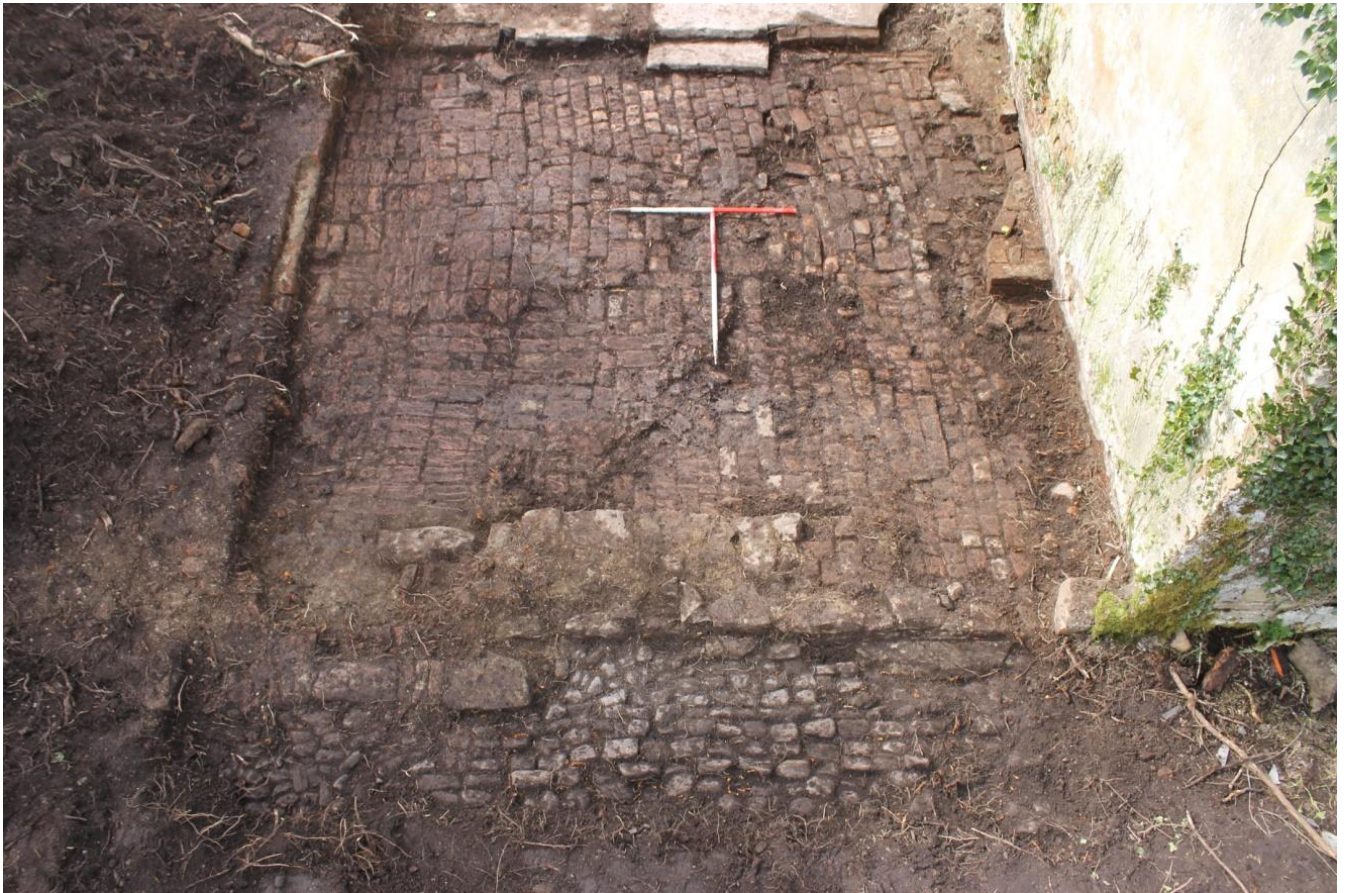
Plate 13: Post-excavation shot of Trench Three showing the brick floor and structural elements of the building (Context No. 302), looking west.

- 3.6.3 Both the cement floor (Context No. 305) and the base of the fireplace (Context No. 304) appeared to be constructed directly upon the brick floor of the structure (Context No. 302). The base of a fireplace (Context No. 304) was encountered along the northern wall of the structure. This feature was constructed of brick and survived to a single course high. The fireplace (Context No. 304) measured 1.3m (north/south) and was the only internal feature exposed within the structure. A noticeable 'step' from the brick floor (Context No. 302) to the cement deposit (Context No. 305) was noted, although the location of spoil here made further investigation of this deposit problematic. The exterior wall of the structure (Context No. 303)

was comprised of rounded boulders bonded with a crumbly beige coloured mortar and was on average 0.5m thick. The wall survived to a single course high, with a maximum recorded height of 0.42m above the brick floor (Context No. 302). Removal of the overburden (Context No. 301) in the exterior of the structure revealed a deposit of cobbles (Context No. 306) which appears to be a continuation of the cobbles encountered during the excavation of Trench Two (Context No. 222)

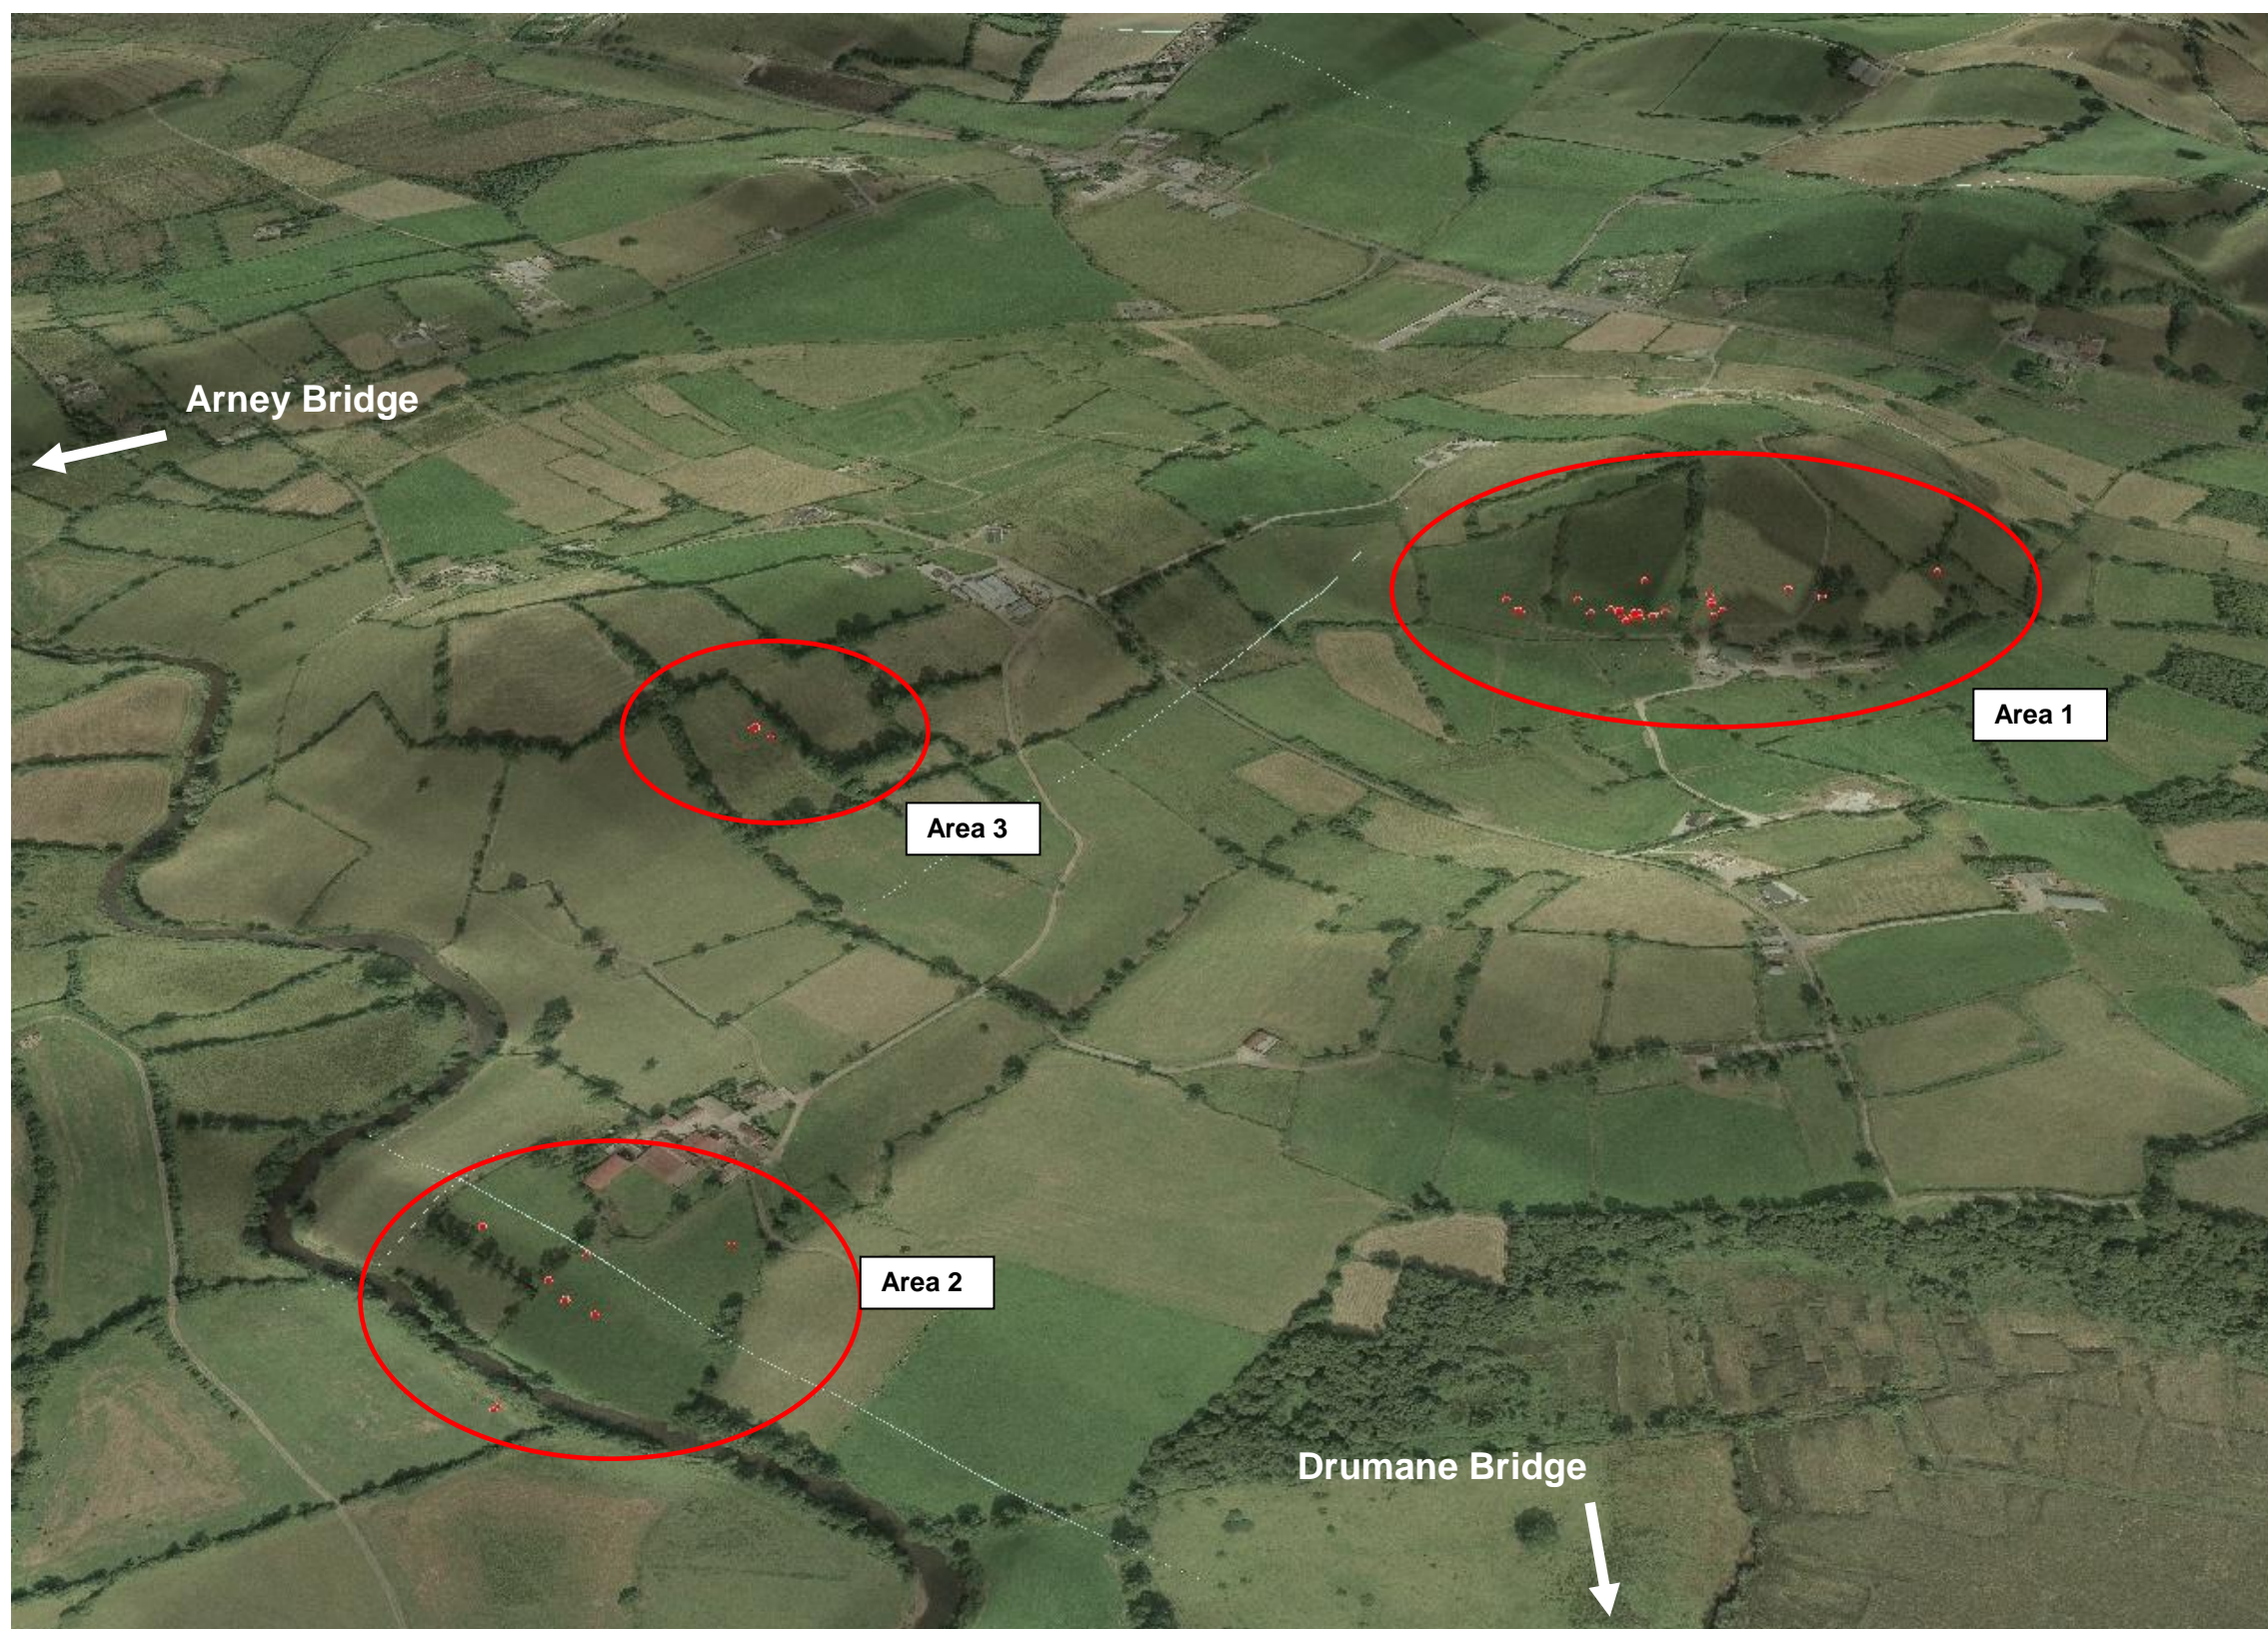
Figure 18: Oblique aerial view of the metal detection find spots looking from the south-east onto the north-west. Ortho-rectified aerial photographs, 2006, draped over Digital Terrain Model visualised in ArcScene 10.2. (Image prepared by Dr Siobhán McDermott, Centre for Archaeological Fieldwork, QUB)
